# Property and Timber Pest Report

Inspection Date: 6 May 2020

Property and Timber Pest Report

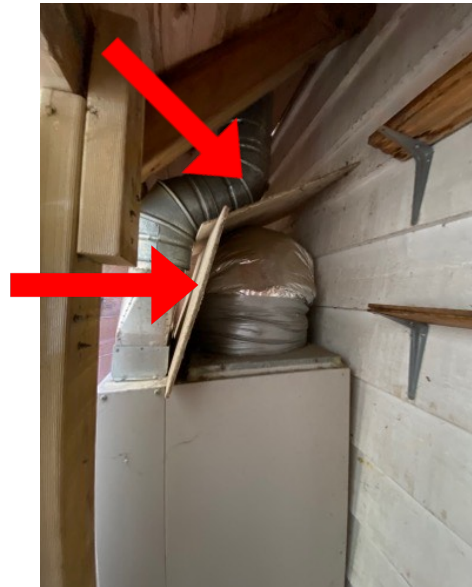
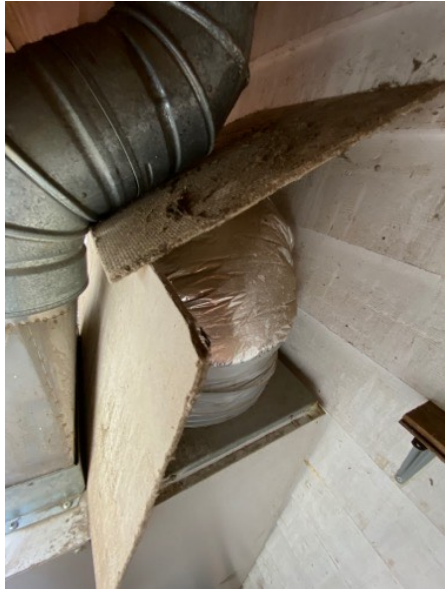
Any exposed edges pose a higher safety hazard and should be painted to encapsulate as a matter of urgency.

As Asbestos Reporting/Testing is outside the scope of this report, I advise once the property is handed over that you consider getting the asbestos tested and if confirmed as asbestos then removed.

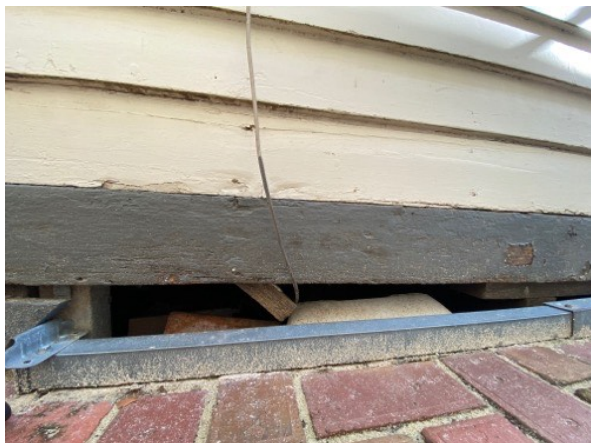
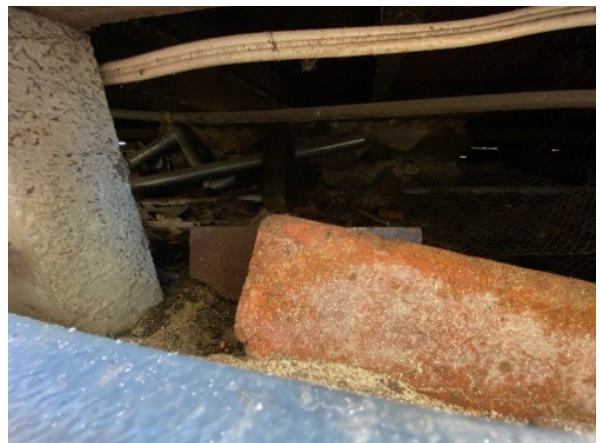
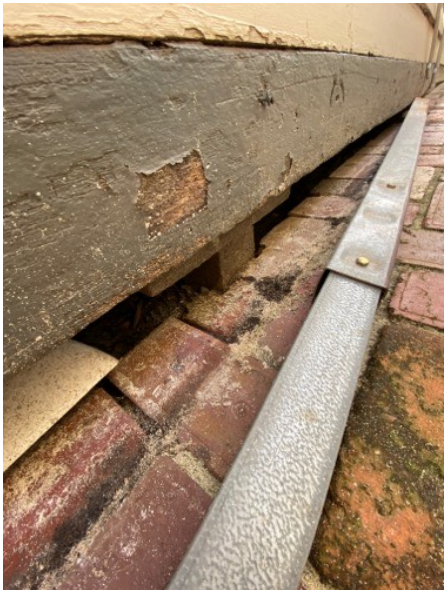
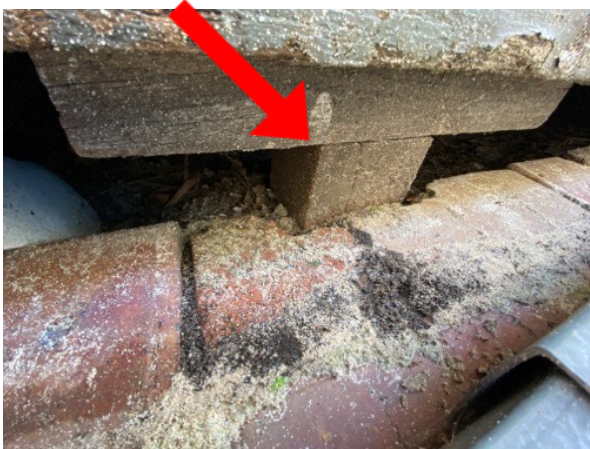
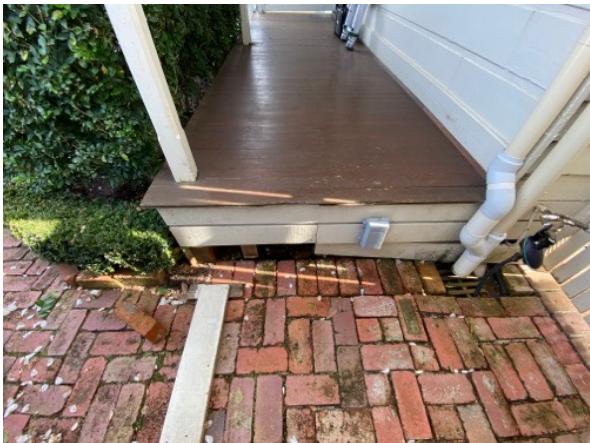
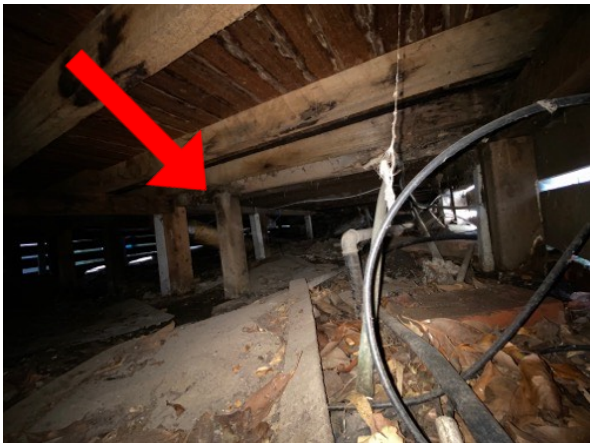
### Major Defect 2.02

Finding: 1 Timber stumps - Suspected deterioration

Although there was no access to the subfloor it was noted that the property has timber stumps. Inspection of the condition of the timber stumps - below the surface of the ground - is excluded from the scope of this report. Where timber stumps are failing replacement of stumps may be required in the short- to medium-term future. Timber stumps are no longer used in current building practices due to their susceptibility to wood rot and deterioration over time. The client should be prepared that in purchasing a property with timber stumps, that the need to restump the property in the short- to medium-term future is likely. It's advised a registered builder, Specialist in re-stumping be contacted for further invasive inspection and replacement of the affected stumps and any structural timbers which also maybe deteriorating. These works should be conducted as soon as possible.

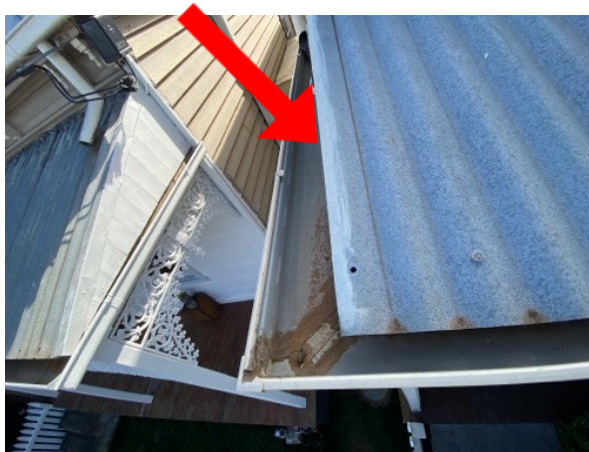
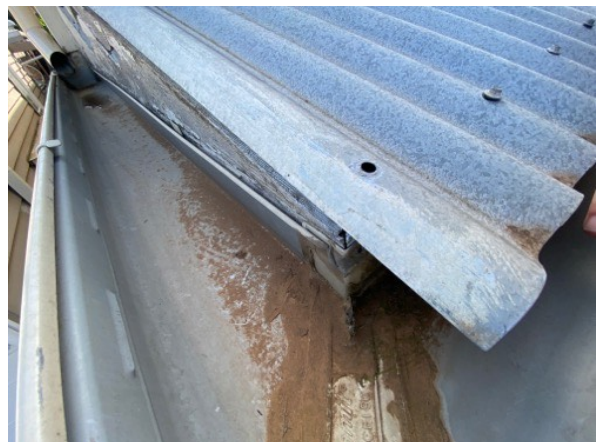
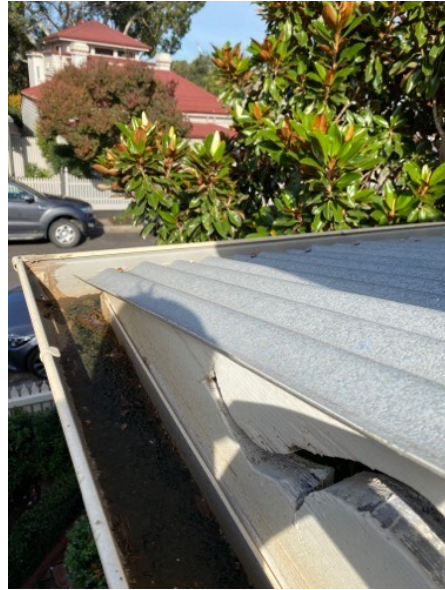
### Minor Defect 3.03

Location: Roof exterior

Finding: Roof plumbing - Flashing inadequate  
The veranda roof is missing a section of roof flashings. Flashings are metal and other materials which are applied to seals and intersections between roof coverings and building elements. They are designed to aid in the weatherproofing of roof joins. Flashings that are not installed adequately or missing are likely to result in further water damage. A roofing plumber should be appointed as soon as possible to install relevant roof plumbing materials, ensuring that no further damage is sustained.

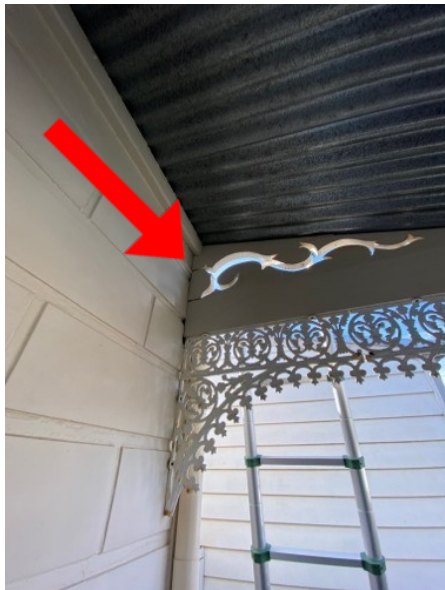
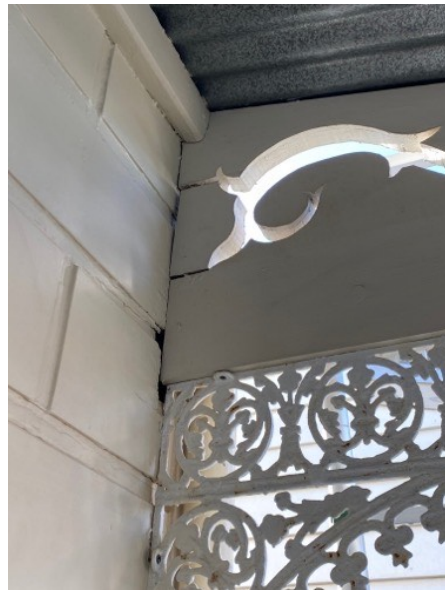
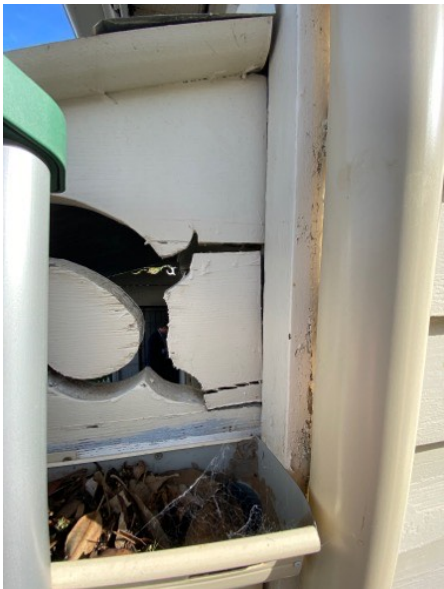
### Minor Defect 3.04

Location: Porch

Finding: Splitting of timber

Splits in sections of the porch timbers that extend to the end or side edge of the timber was evident. Works to replace or re-fix this timber is recommended as soon as possible. A registered builder can conduct these works.

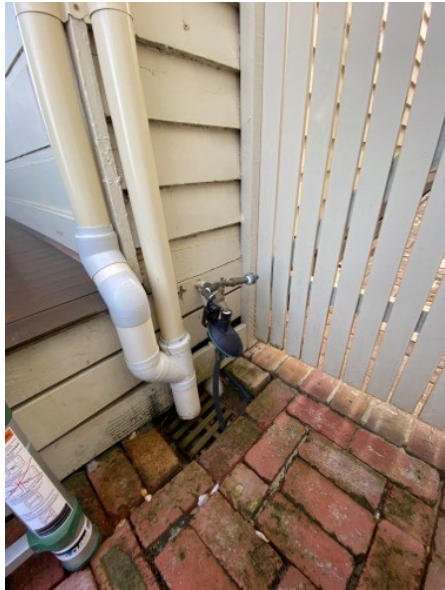
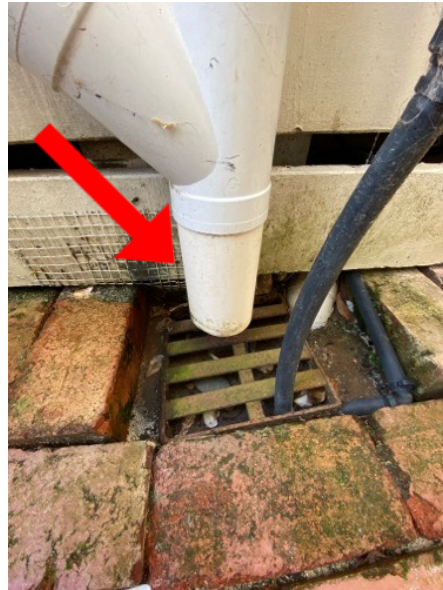
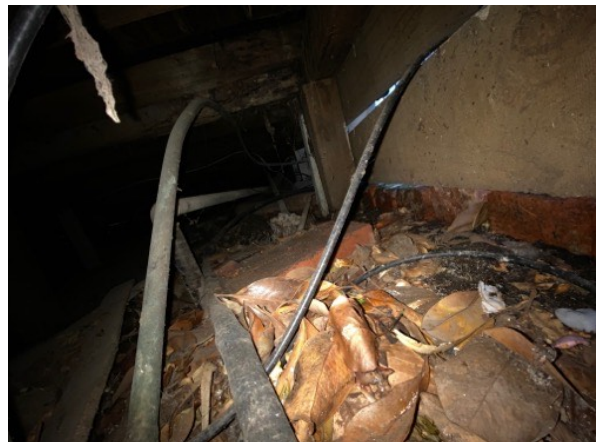
### Minor Defect 3.05

Location: All External Areas

Finding: Stormwater drain - Not connected

The roof plumbing is not adequately connected to stormwater drainage on the site. This disconnection negatively impacts the functional capacity of the roof plumbing. Where roof plumbing doesn't drain adequately, the area at the base perimeter can become excessively damp. It is highly recommended that a plumber be appointed to further inspect the area and to install adequate drainage equipment where necessary.

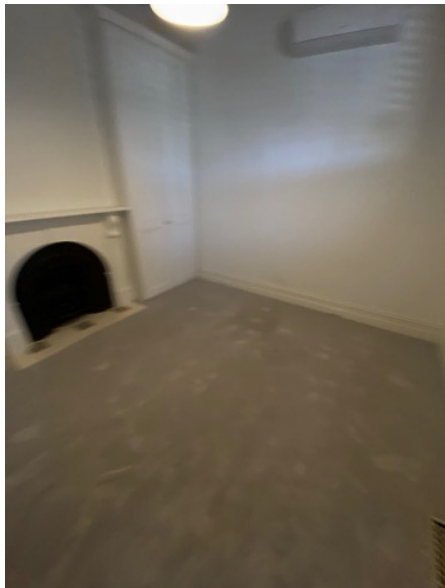
### Minor Defect 3.06

Finding: Flooring - Uneven

The internal flooring in this area is out of level and uneven. Uneven flooring is likely to indicate defects such as expected movement of the foundations of the property or likely due to failing subfloor stumps. It is advised that the flooring be closely monitored to identify any further movement. Where flooring remains relatively unchanged for an extended period of time, it is likely that this defect has been caused by expected movement of the foundations of the property. However, where flooring is still moving a further, more invasive inspection of the subfloor structures and stumps in this area is required.

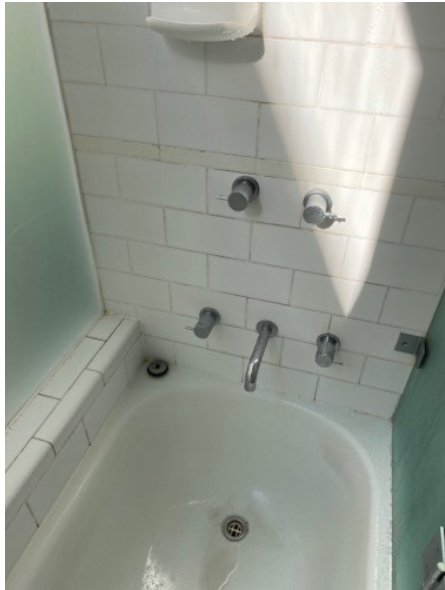
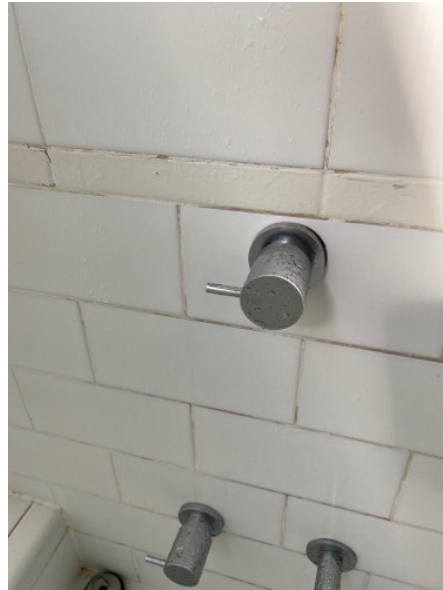
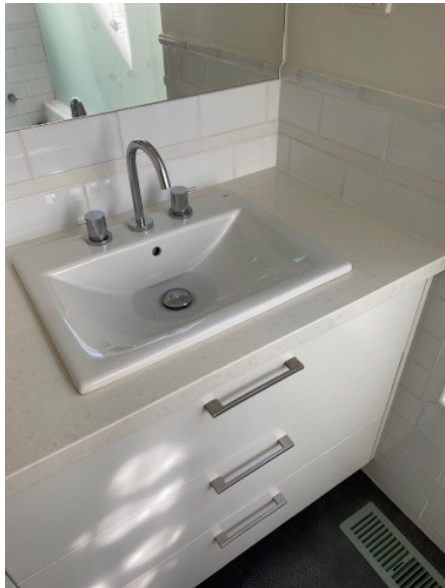
### Minor Defect 3.07

Location: Bathroom

Finding: Tap - Water hammer

These taps shows evidence of water hammer being present. Water hammer, a pressure surge resulting when a fluid is forced to suddenly change direction, is a common defect in plumbing fittings, particularly those that are aged and not frequently maintained. A licensed plumber should be appointed as soon as possible to replace any affected tap hardware and perform any remedial works as necessary.

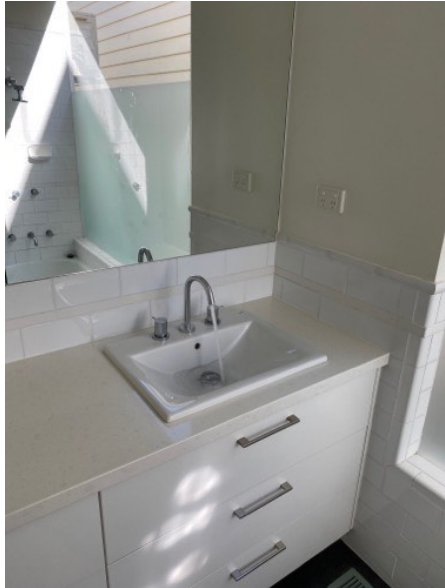
### Minor Defect 3.08

Location: Bathroom

Finding: Blocked drains

The wet area drain appears to be blocked at the time of inspection. Blockages prevent building elements from operating as intended. A licensed plumber should be consulted as soon as possible to perform any remedial works where required.

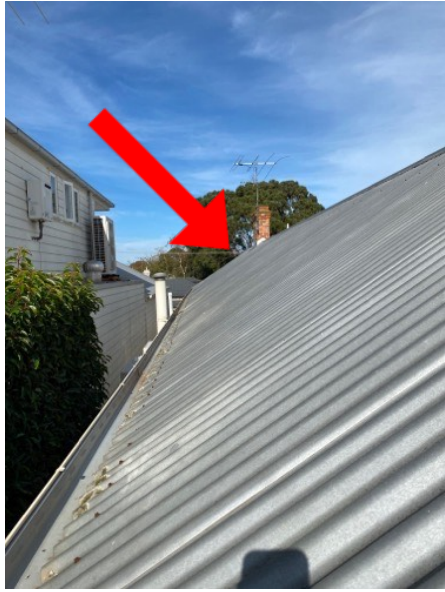
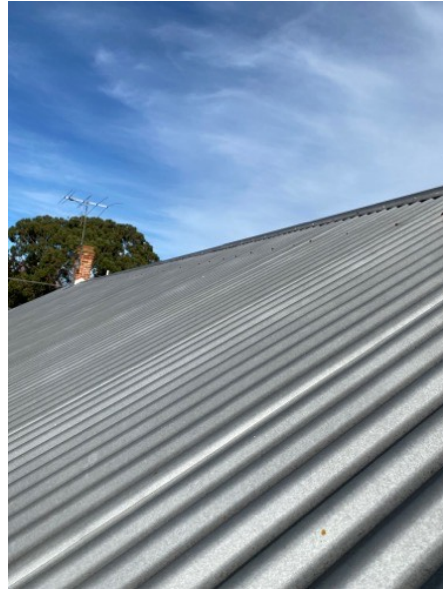
### Minor Defect 3.09

Location: Roof exterior

Finding: Roofing Screws - Missing

Roofing screws have not been installed on sections of the roof from the original renovation. All building elements play a role in the operation and function of the overall structure and its performance. Replacement of any missing roof screws should be conducted as soon as possible to ensure that no damage or functional issues occur to associated building materials.

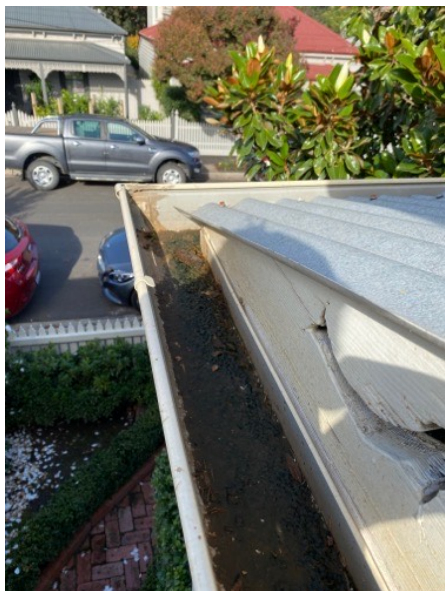
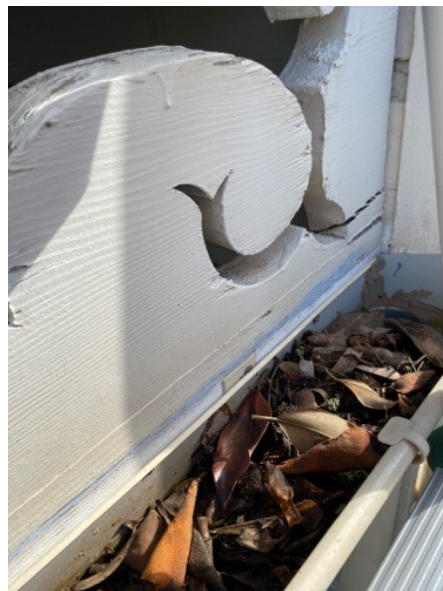
### Minor Defect 3.10

Location: Roof exterior

Finding: Gutters - Blocked

Roof plumbing structures such as guttering and downpipes should be free of all debris to prevent blockages. Blocked gutters are likely to lead to high levels of moisture in the affected areas and will not only cause rust and decay but can also provide conditions that are conducive to termite and timber pest activity. Blockages in gutters should therefore be removed immediately to ensure dry conditions are maintained. It is highly advised that blocked gutters be removed by the homeowner or a general handyperson as soon as possible.

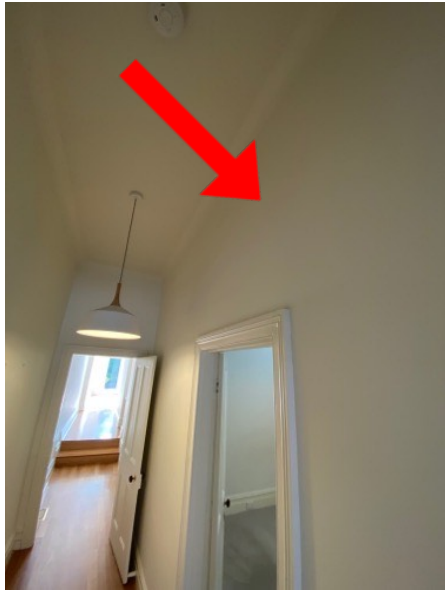
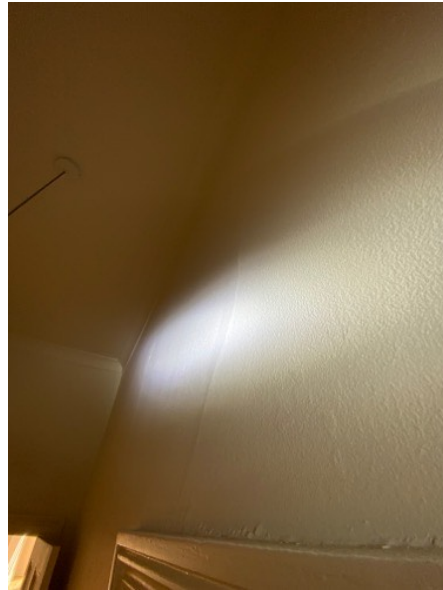
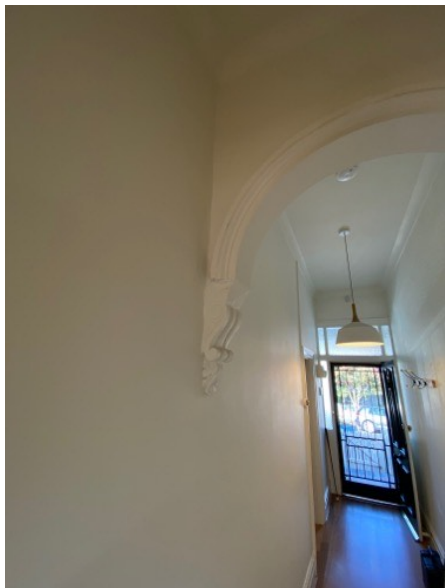
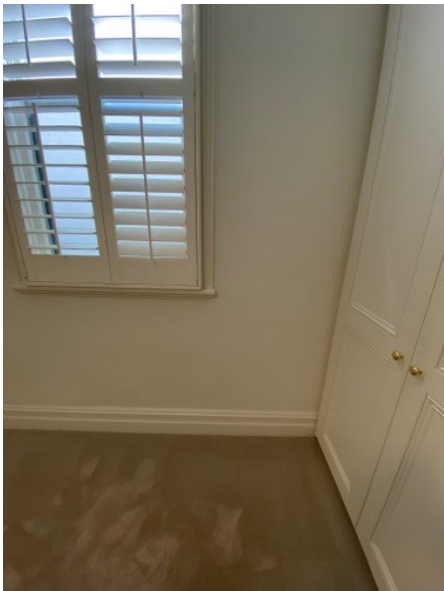
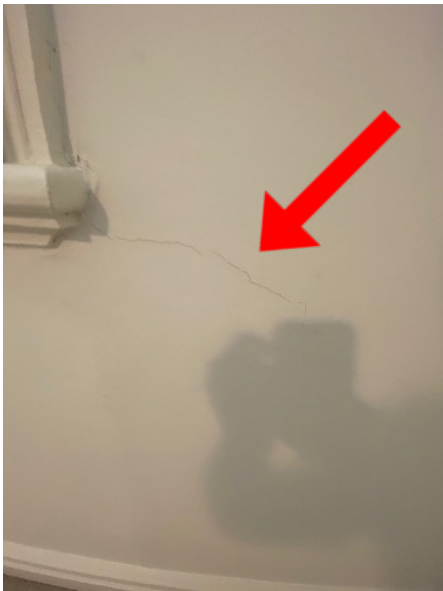
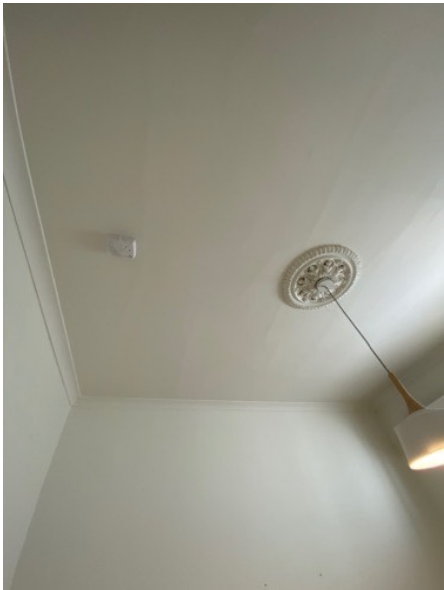
### Minor Defect 3.11

Location: All Internal Areas

Finding: Cracks & Crack Repairs

Although cracks and crack repairs are quite noticeable, they are often only considered to be an appearance defect, and usually do not indicate any structural damage. Generally, the cause of the cracks is due to general building movement, indicative of a separation between building materials and finishes (e.g. paint, plaster, etc.) along joins.

Cracking of this nature can generally be repaired with minor sanding, filling and/or repainting. Such works should be performed by a qualified painter or a general handyman.

Monitoring of all cracking should be conducted frequently. Always contact a building inspector should cracks widen, lengthen, or become more numerous.

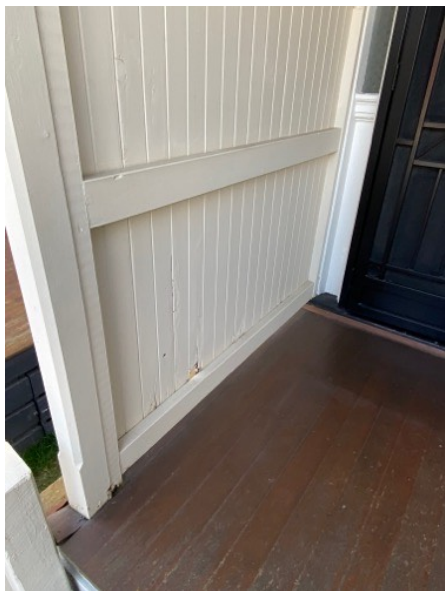
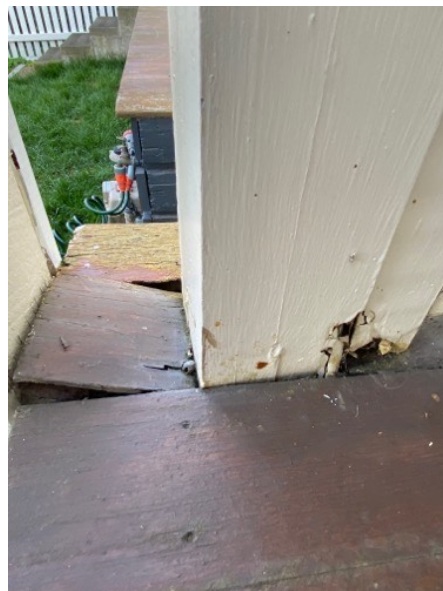
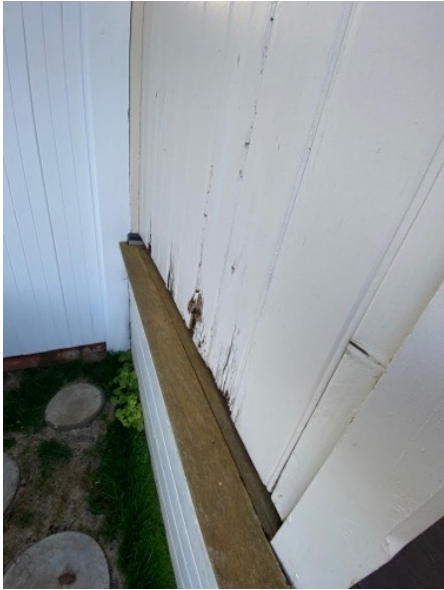
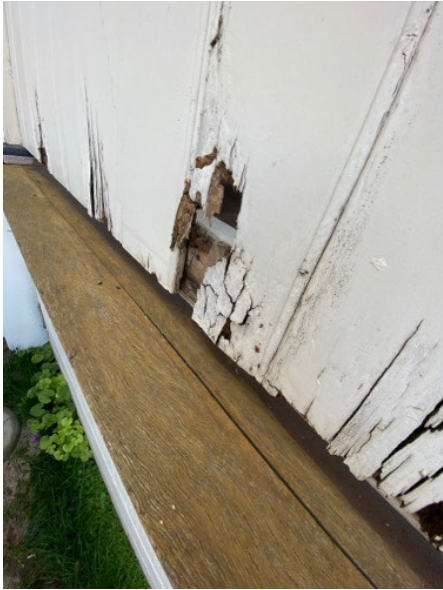
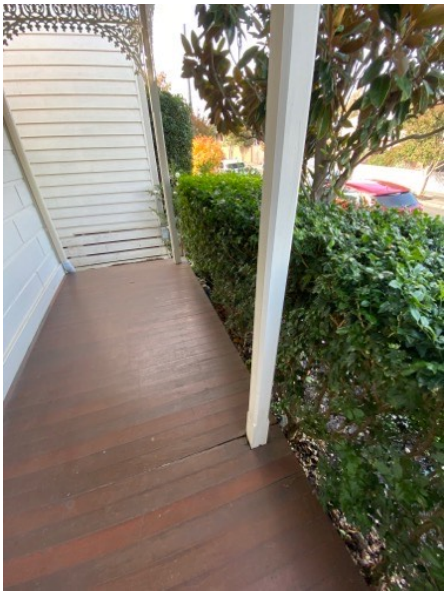
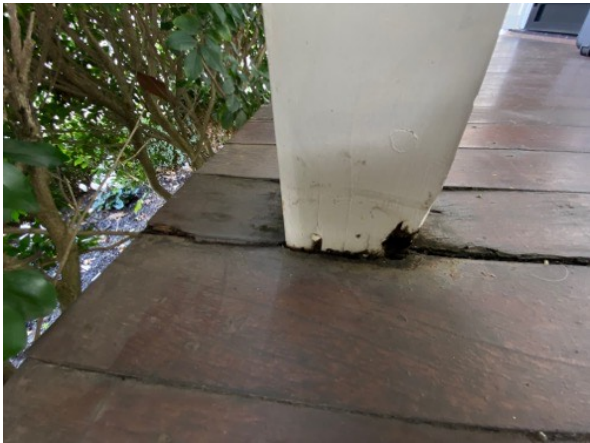
### Minor Defect 3.12

Location: All External Areas

Finding: Wood rot

Wood rot and rot repairs was evident to these external timbers and windows. Wood rot which also known as Fungal Decay, occurs when timbers and other cellulose type building materials are exposed to damp conditions on a continual basis. Replacement of affected timbers may then be a necessary step in protecting surrounding building elements from such deterioration. Where wood rot is found to be present to any structural timber, the replacement of the affected timber is required immediately. A qualified carpenter or registered builder may also be required to replace affected building materials.

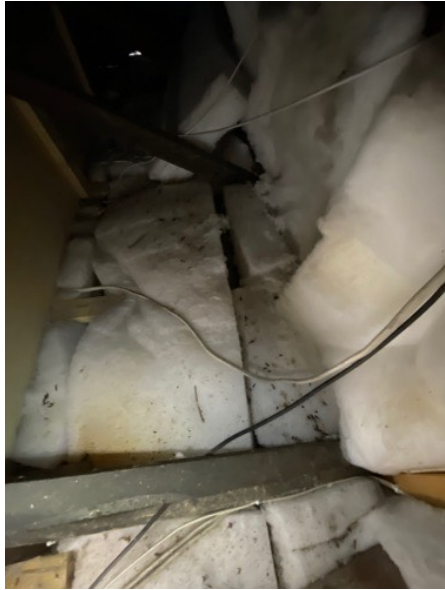
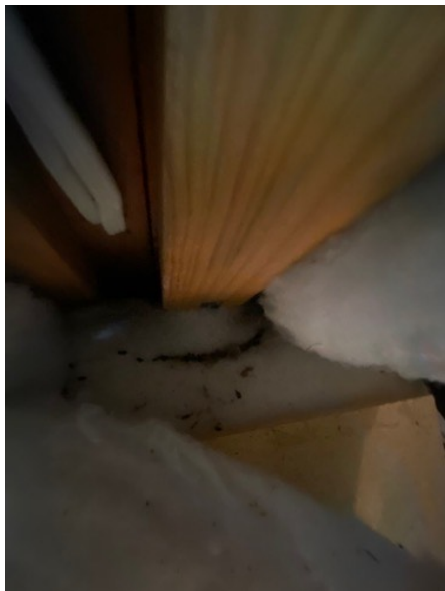
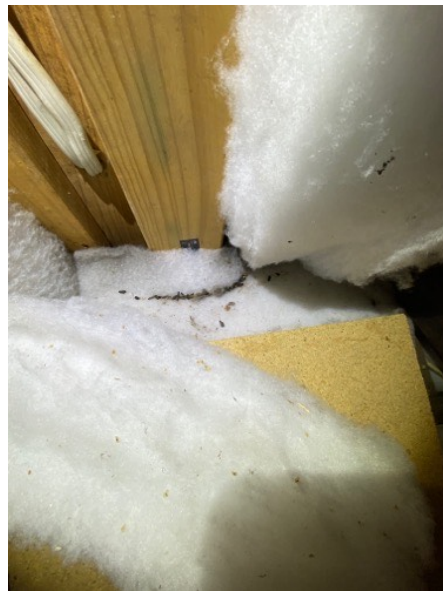
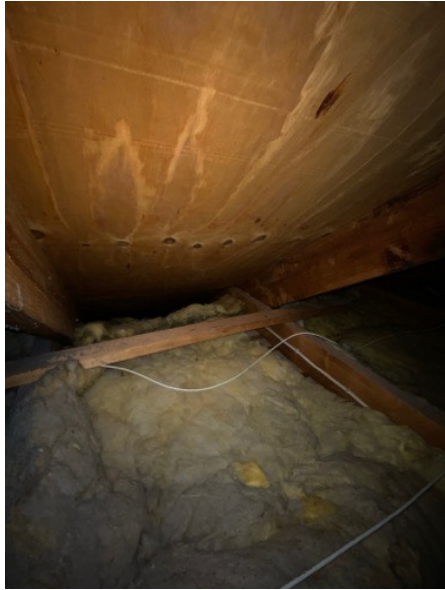
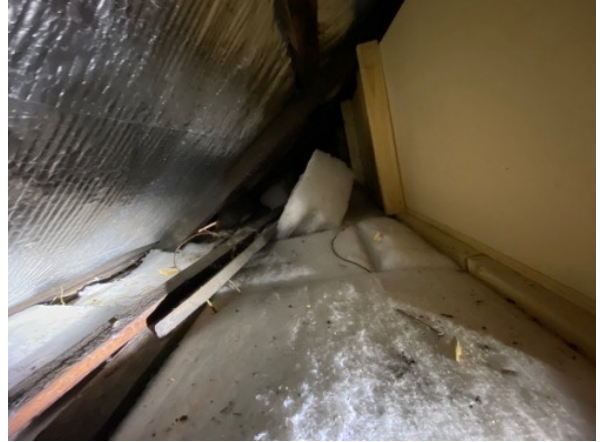
### Minor Defect 3.13

Location: Roofspace

Finding: Evidence of Vermin

Evidence of pests or rodents was present in the roof space at time of inspection. A licensed pest controller should be appointed to free the roof void of any pests and to install deterrents or seal access points to ensure that rodents cannot enter the roof space as easily.

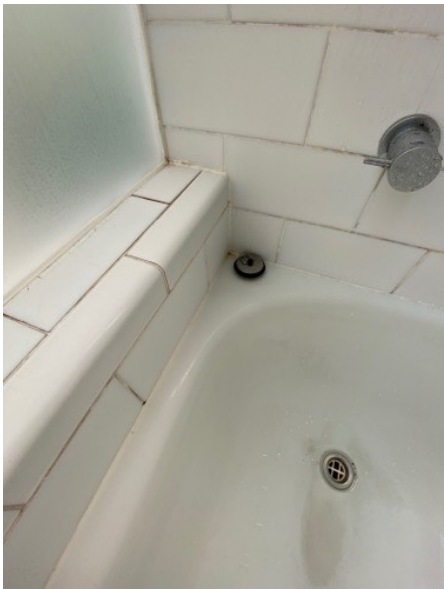
### Minor Defect 3.14

Location: Wet Area's

Finding: Sealants Deteriorating

It was noted on inspection that sealant or grout is degraded to the tiled shower alcove and or other areas of the bathroom and kitchen which can allow water to reach the structural materials.

Different materials and floor areas move at different rates, generally causing cracking to grout or sealant at this point. A flexible sealant is required to allow for expected expansion and contraction, while keeping the joint water tight and protective of all associated building materials.

There appears to be mould to the sealant and grout which will likely require scraping out and replacement.

Flexible and mould resistant materials should be applied to affected areas to prevent any subsequent water damage that is likely to occur. Regular maintenance and replacement of damage or missing or damaged sealant and grout is highly recommended to the wet areas, as this is a regular wear and tear defect. Sealant and grouting in areas that come into regular contact with water should be maintained for the long term care of your property.

A sealant specialist or tiling contractor should be appointed to complete these works as soon as possible.

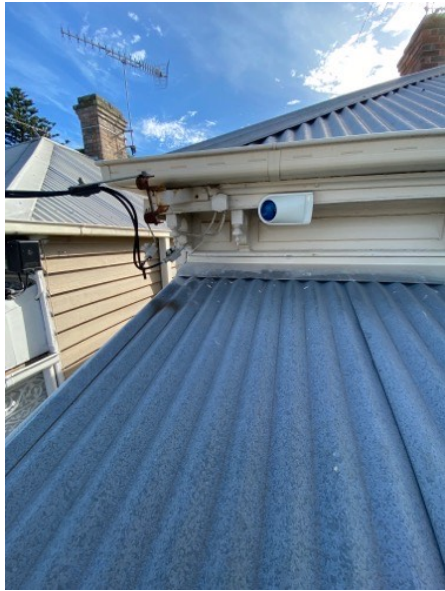
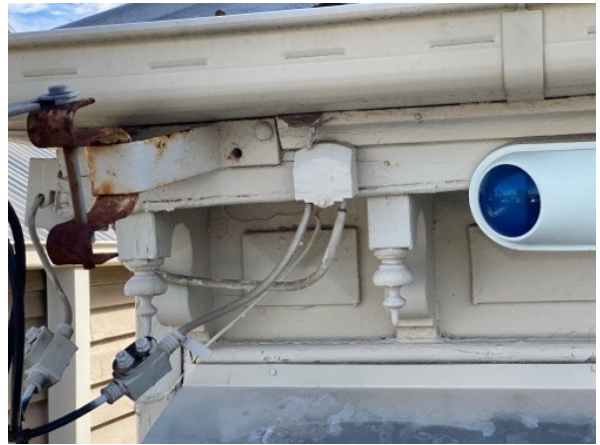
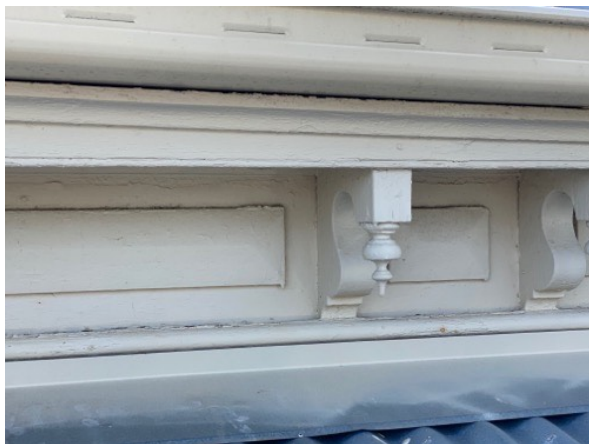
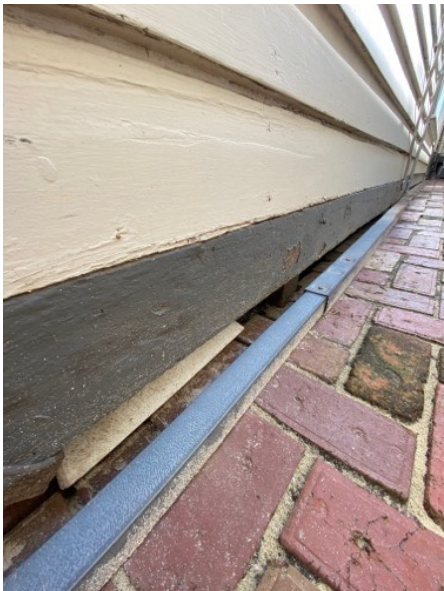
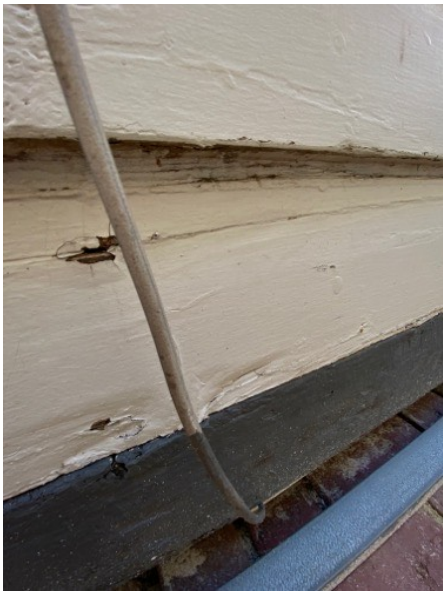
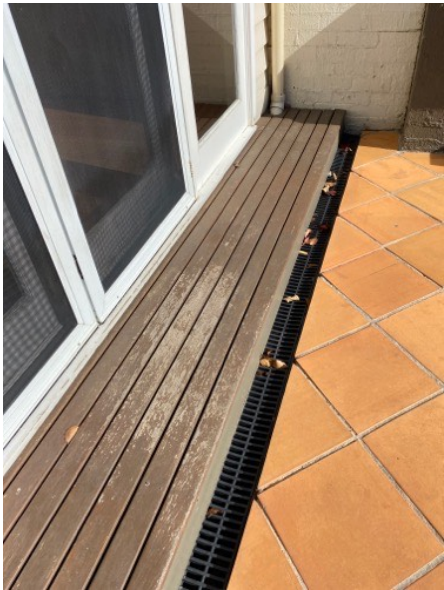
### Minor Defect 3.15

Location: All External Areas

Finding: Timber - exposed to weather  
External timbers/weather boards that are frequently exposed to harsh weather conditions require adequate protection in order to maintain their condition. Where timbers have not been painted or treated adequately, general deterioration is likely to occur at an accelerated rate. If left unattended, replacement of these timbers is likely to be necessary in the short-term future. Adequate treatment of these timbers is required as soon as possible by a painting contractor or general handyman.

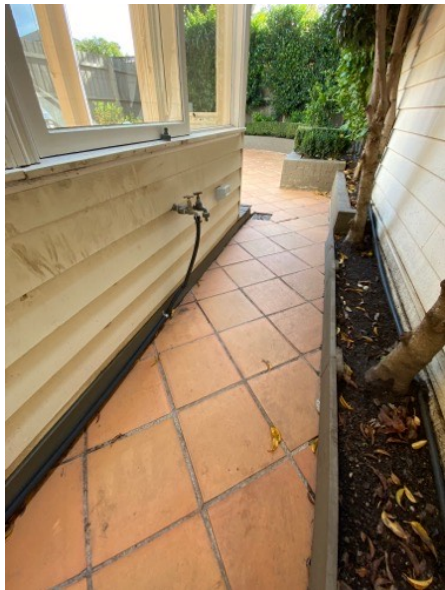
Location: All External Areas

Finding: 1 Building materials in direct ground contact - conducive to termites  
Where stored timber and house barge boards are in contact with ground, they can retain moisture or dampness and become highly conducive to termite activity. External timbers when met with excessive moisture begin to decay, develop wood rot and become conducive to termite activity.  
It's advised the removal of any timbers that are not part of a building structure that may be conducive to termite activity. Due to the location of the property and building timbers in contact with ground it's highly advised that a termite treatment around the property is conducted as there was no evidence of a previous termite management system in place.
