# Property and Timber Pest Report

Inspection Date: 6 May 2020

Property and Timber Pest Report

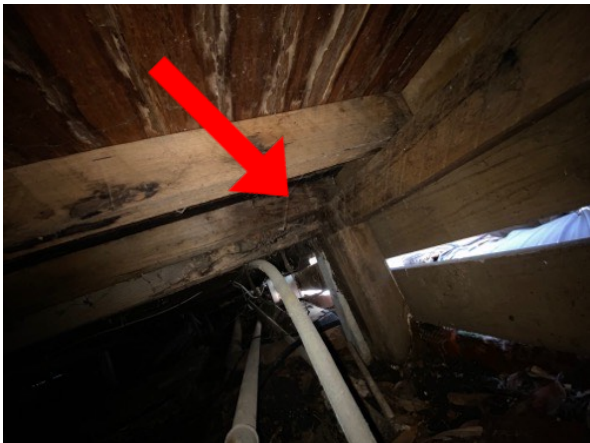
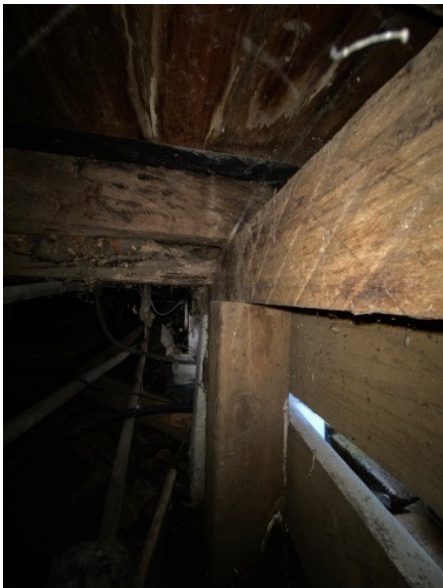
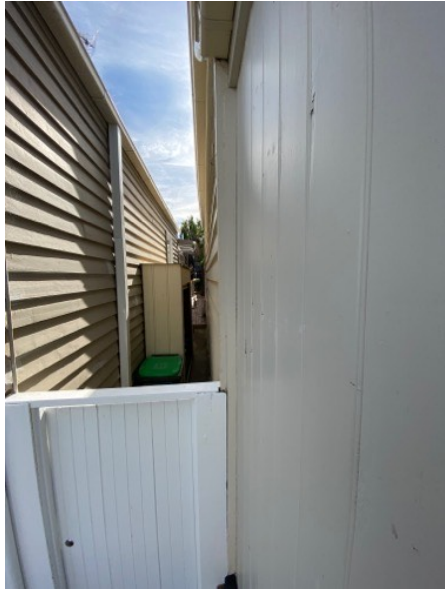
### Major Defect 2.02

Finding: 1 Timber stumps - Suspected deterioration

Although there was no access to the subfloor it was noted that the property has timber stumps. Inspection of the condition of the timber stumps - below the surface of the ground - is excluded from the scope of this report. Where timber stumps are failing replacement of stumps may be required in the short- to medium-term future. Timber stumps are no longer used in current building practices due to their susceptibility to wood rot and deterioration over time. The client should be prepared that in purchasing a property with timber stumps, that the need to restump the property in the short- to medium-term future is likely. It's advised a registered builder, Specialist in re-stumping be contacted for further invasive inspection and replacement of the affected stumps and any structural timbers which also maybe deteriorating. These works should be conducted as soon as possible.

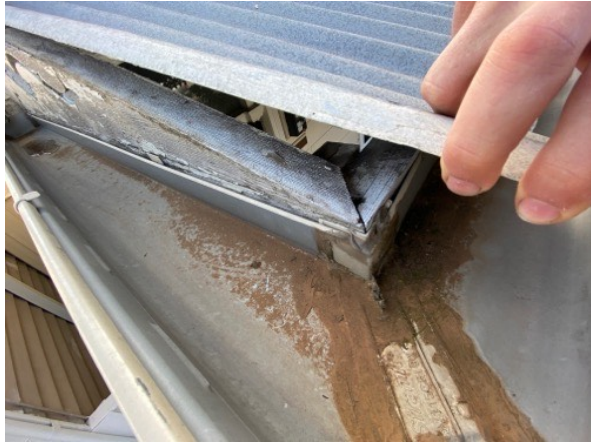
### Minor Defect 3.03

Finding: Roof plumbing - Flashing inadequate  
The veranda roof is missing a section of roof flashings. Flashings are metal and other materials which are applied to seals and intersections between roof coverings and building elements. They are designed to aid in the weatherproofing of roof joins. Flashings that are not installed adequately or missing are likely to result in further water damage. A roofing plumber should be appointed as soon as possible to install relevant roof plumbing materials, ensuring that no further damage is sustained.

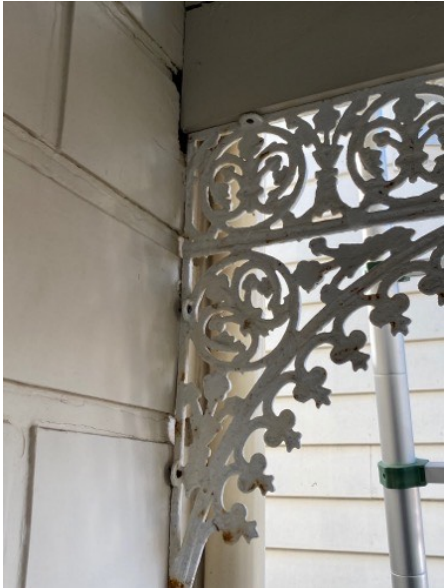
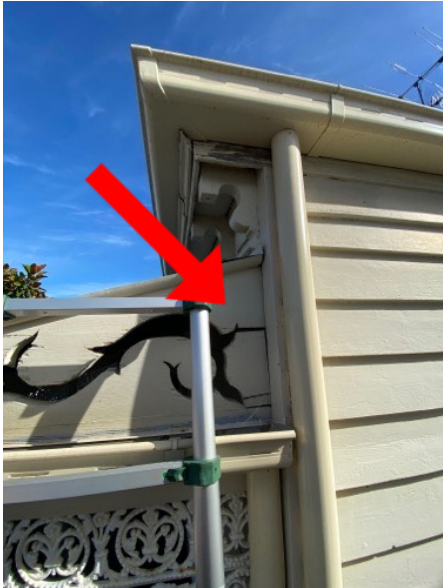
### Minor Defect 3.04

Location: Porch

Splits in sections of the porch timbers that extend to the end or side edge of the timber was evident. Works to replace or re-fix this timber is recommended as soon as possible. A registered builder can conduct these works.

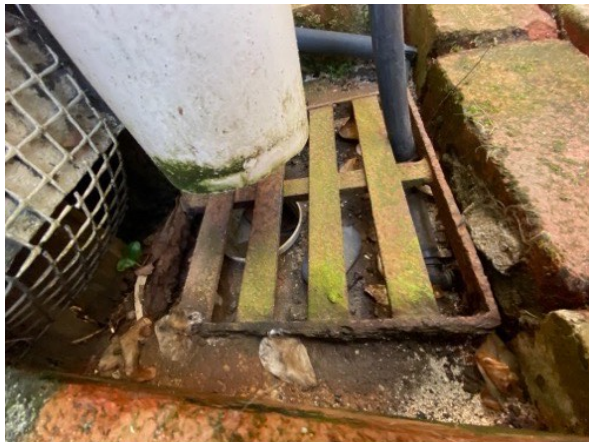
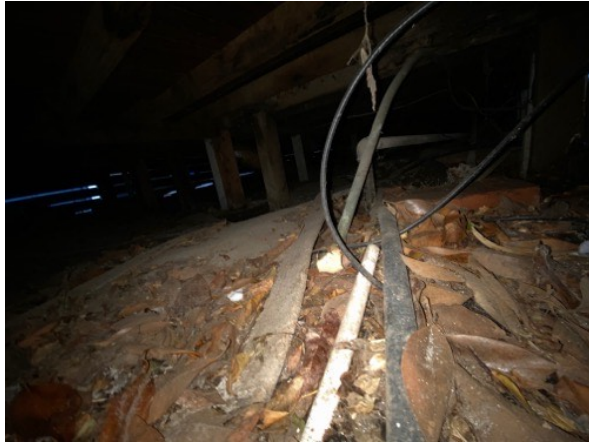
### Minor Defect 3.05

Location: All External Areas

Finding: Stormwater drain - Not connected

The roof plumbing is not adequately connected to stormwater drainage on the site. This disconnection negatively impacts the functional capacity of the roof plumbing. Where roof plumbing doesn't drain adequately, the area at the base perimeter can become excessively damp. It is highly recommended that a plumber be appointed to further inspect the area and to install adequate drainage equipment where necessary.

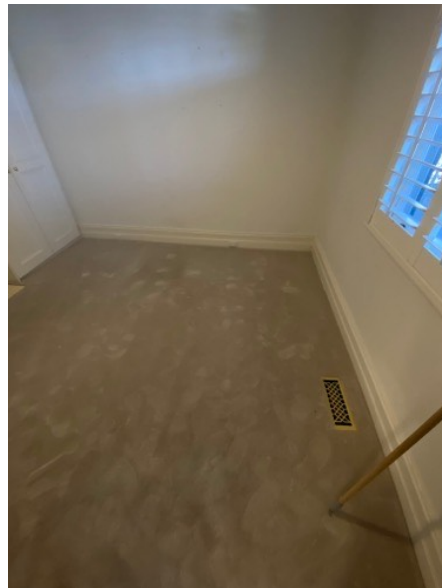
### Minor Defect 3.06

Location: All Internal Areas

Finding: Flooring - Uneven

The internal flooring in this area is out of level and uneven. Uneven flooring is likely to indicate defects such as expected movement of the foundations of the property or likely due to failing subfloor stumps. It is advised that the flooring be closely monitored to identify any further movement. Where flooring remains relatively unchanged for an extended period of time, it is likely that this defect has been caused by expected movement of the foundations of the property. However, where flooring is still moving a further, more invasive inspection of the subfloor structures and stumps in this area is required.

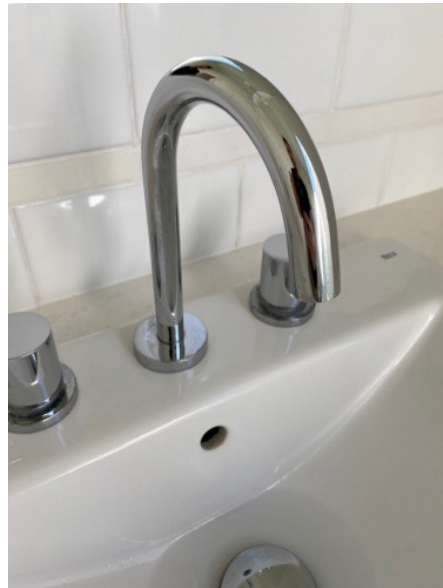
### Minor Defect 3.07

Location: Bathroom

Finding: Tap - Water hammer

These taps shows evidence of water hammer being present. Water hammer, a pressure surge resulting when a fluid is forced to suddenly change direction, is a common defect in plumbing fittings, particularly those that are aged and not frequently maintained. A licensed plumber should be appointed as soon as possible to replace any affected tap hardware and perform any remedial works as necessary.

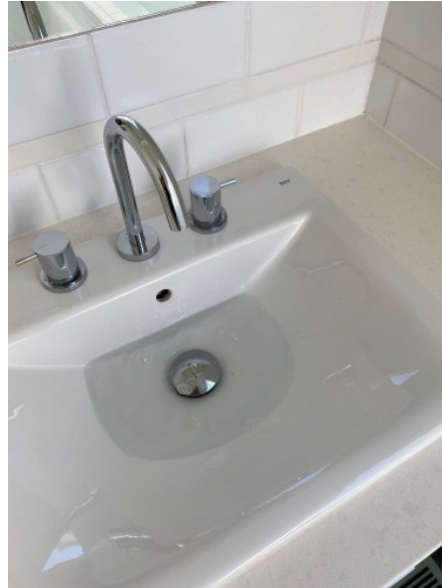
### Minor Defect 3.08

Location: Bathroom

Finding: Blocked drains

The wet area drain appears to be blocked at the time of inspection. Blockages prevent building elements from operating as intended. A licensed plumber should be consulted as soon as possible to perform any remedial works where required.

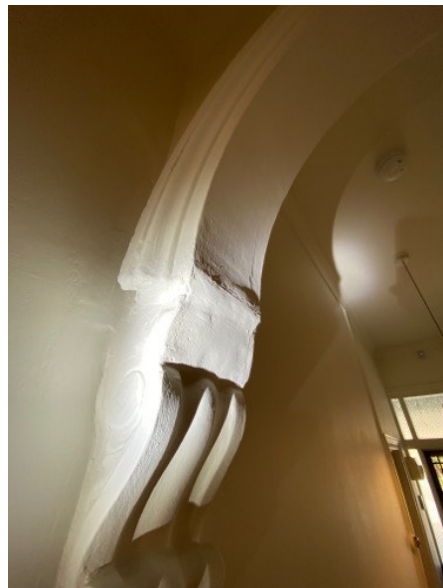
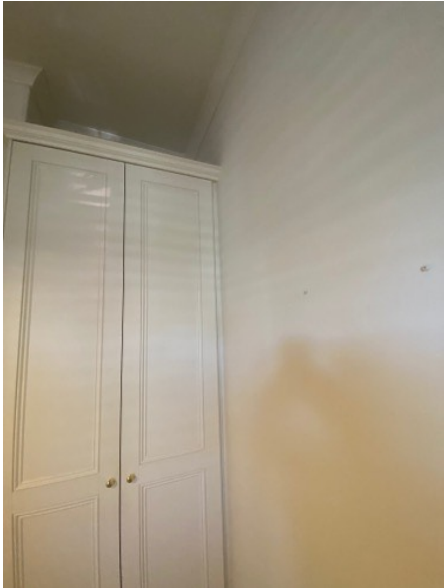
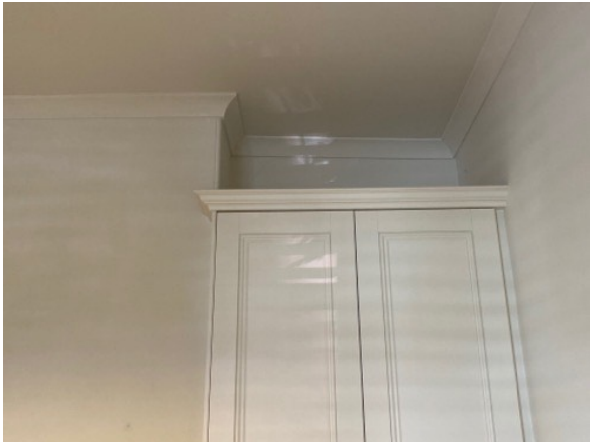
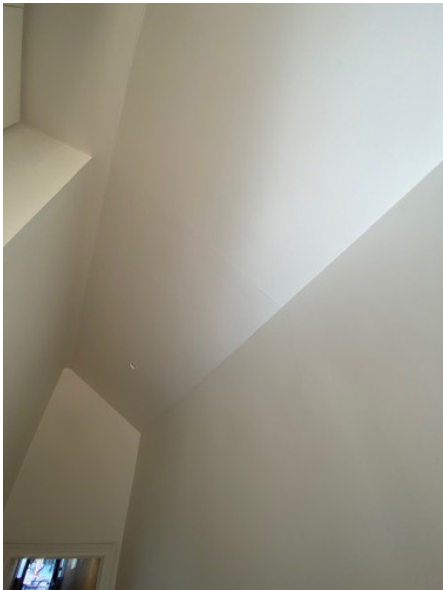
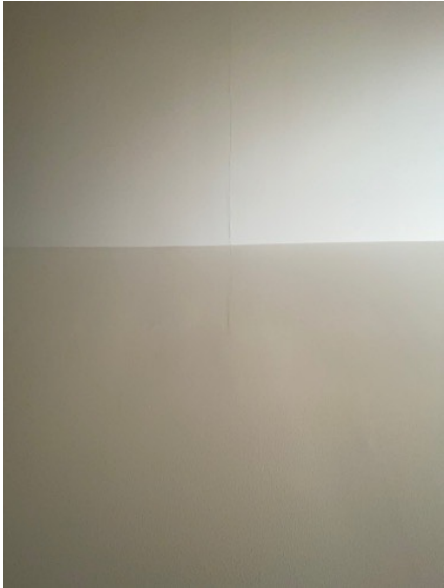
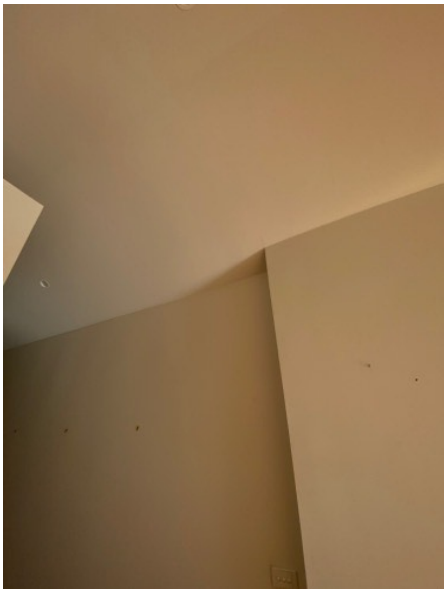
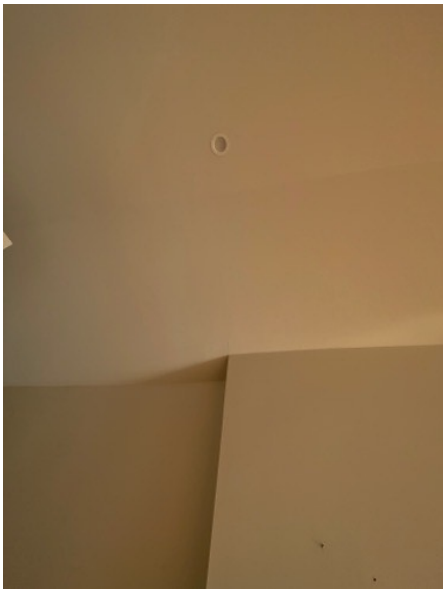
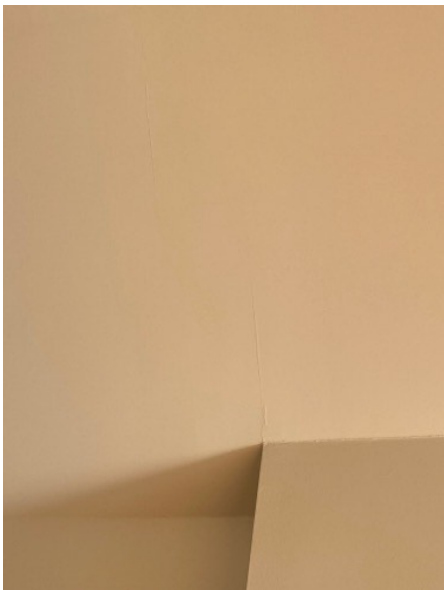
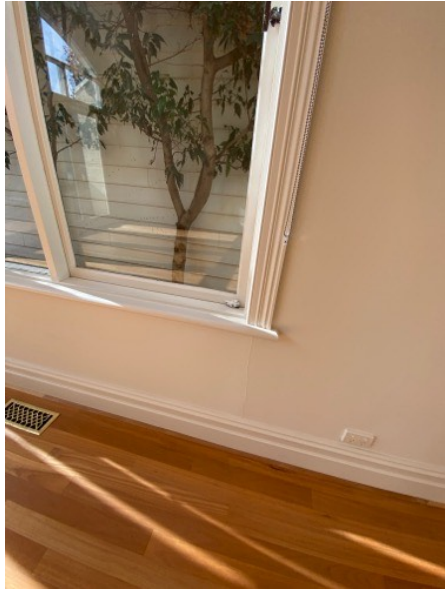
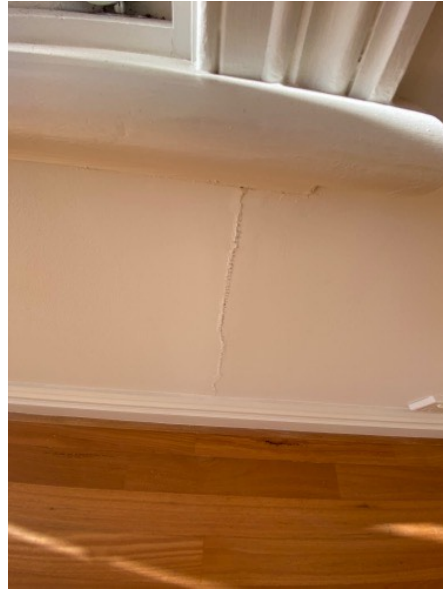
### Minor Defect 3.11

Finding: Cracks & Crack Repairs

Although cracks and crack repairs are quite noticeable, they are often only considered to be an appearance defect, and usually do not indicate any structural damage. Generally, the cause of the cracks is due to general building movement, indicative of a separation between building materials and finishes (e.g. paint, plaster, etc.) along joins.

Cracking of this nature can generally be repaired with minor sanding, filling and/or repainting. Such works should be performed by a qualified painter or a general handyman.

Monitoring of all cracking should be conducted frequently. Always contact a building inspector should cracks widen, lengthen, or become more numerous.

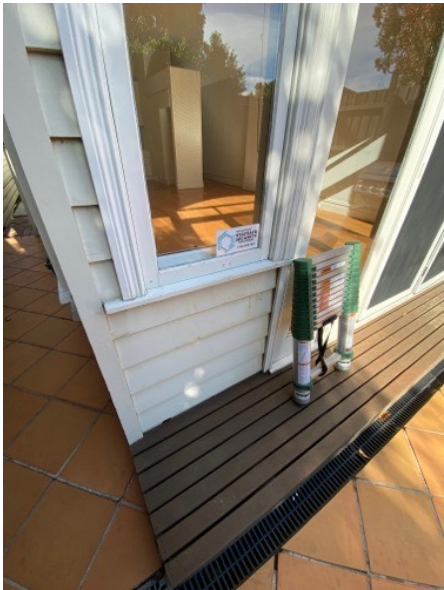
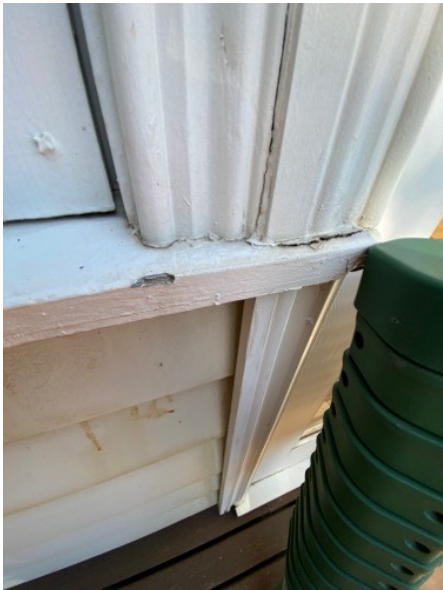
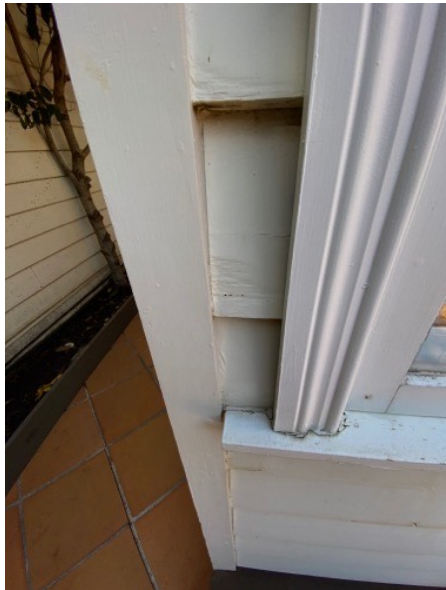
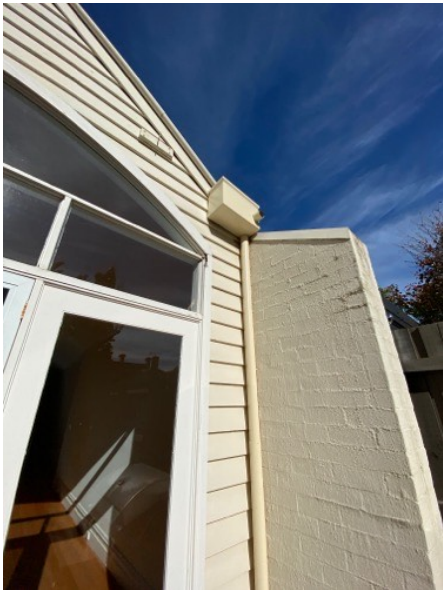
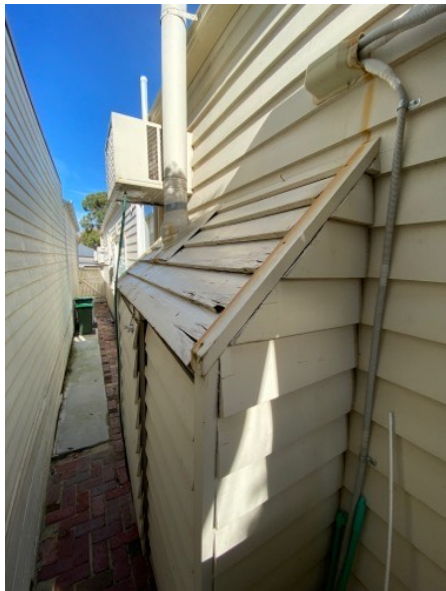
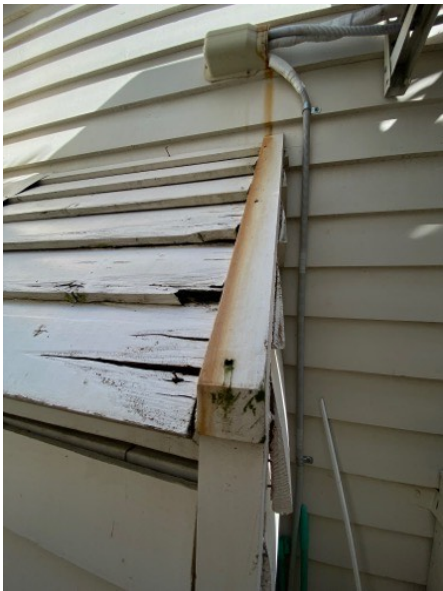
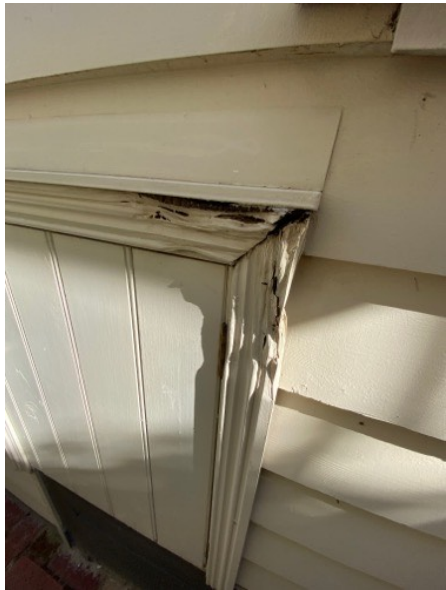
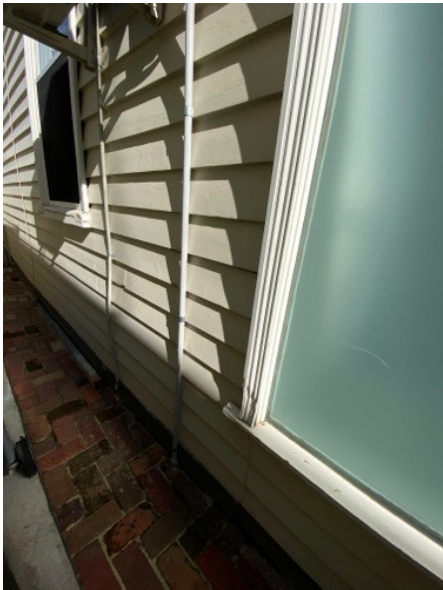
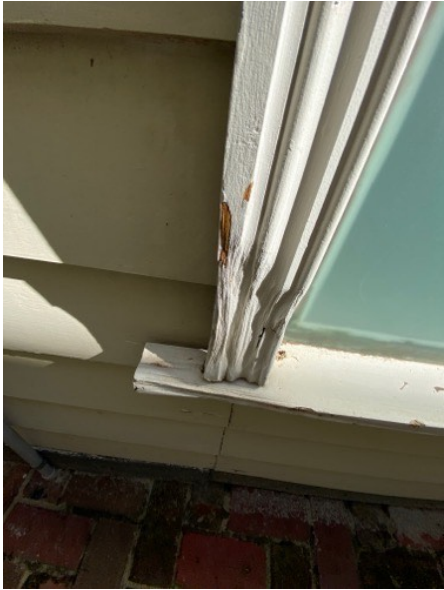
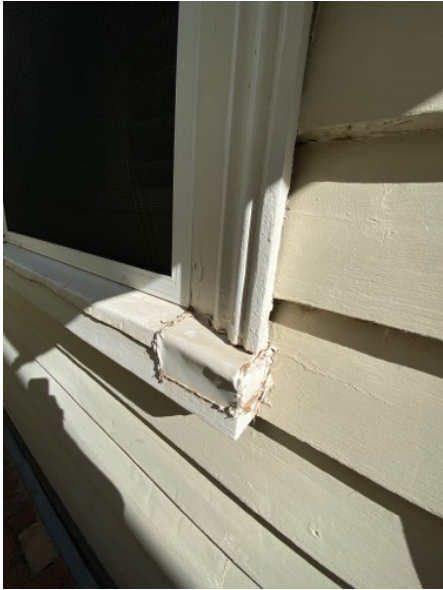
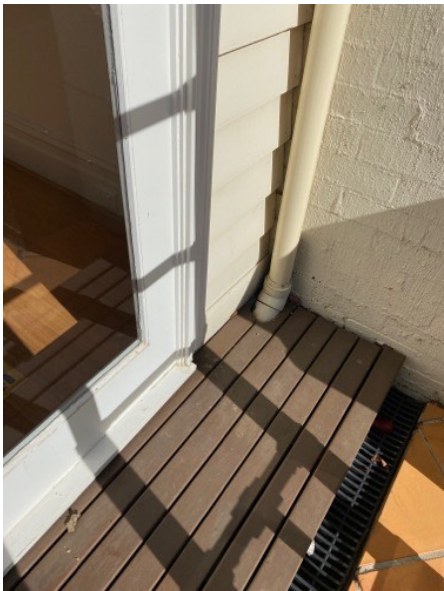
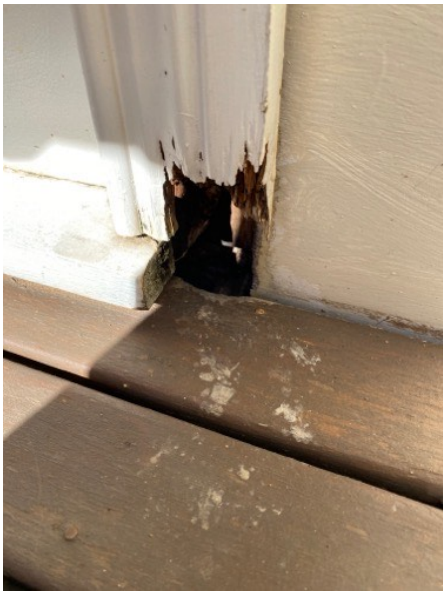
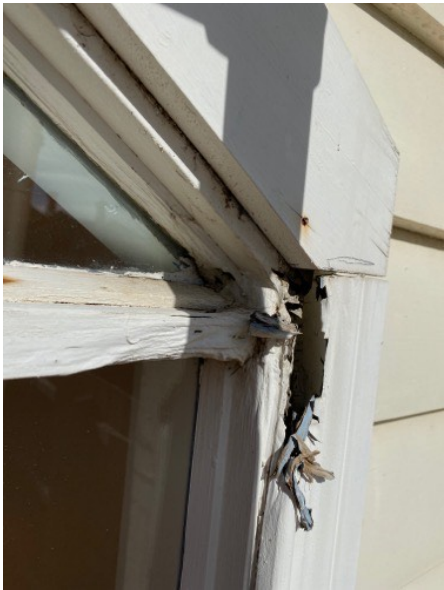
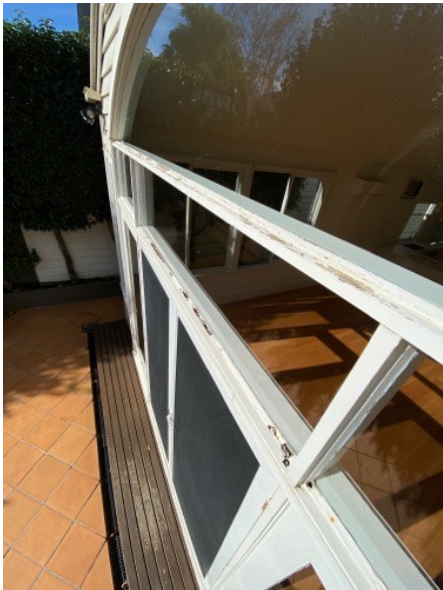
### Minor Defect 3.12

Location: All External Areas

Finding: Wood rot

Wood rot and rot repairs was evident to these external timbers and windows. Wood rot which also known as Fungal Decay, occurs when timbers and other cellulose type building materials are exposed to damp conditions on a continual basis. Replacement of affected timbers may then be a necessary step in protecting surrounding building elements from such deterioration. Where wood rot is found to be present to any structural timber, the replacement of the affected timber is required immediately. A qualified carpenter or registered builder may also be required to replace affected building materials.

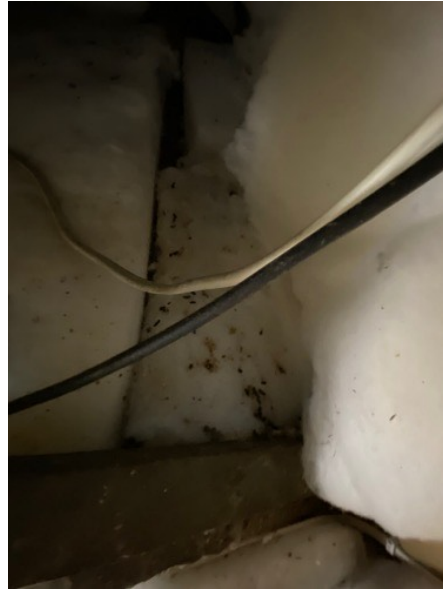
### Minor Defect 3.13

Location: Roofspace

Finding: Evidence of Vermin

Evidence of pests or rodents was present in the roof space at time of inspection. A licensed pest controller should be appointed to free the roof void of any pests and to install deterrents or seal access points to ensure that rodents cannot enter the roof space as easily.

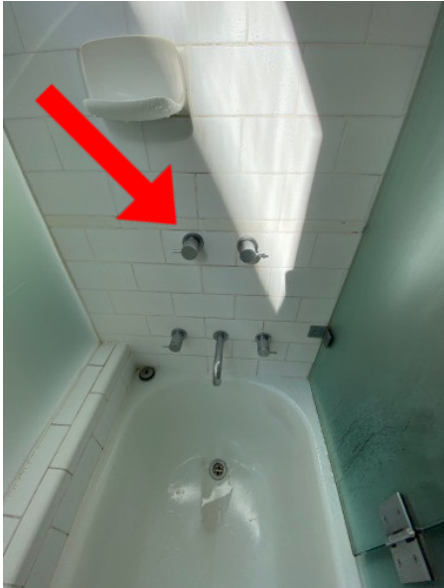
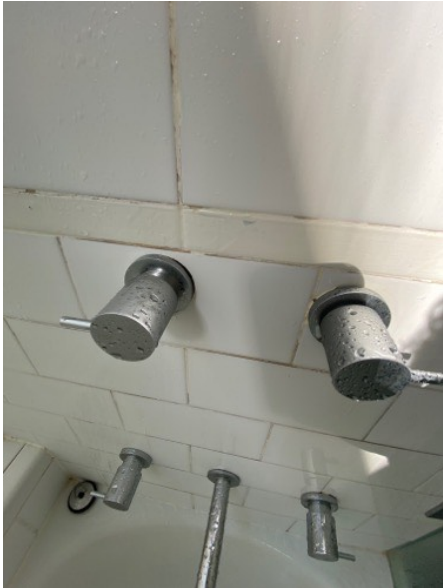
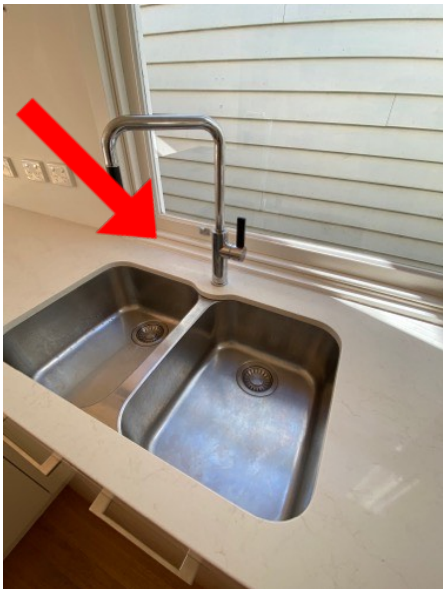
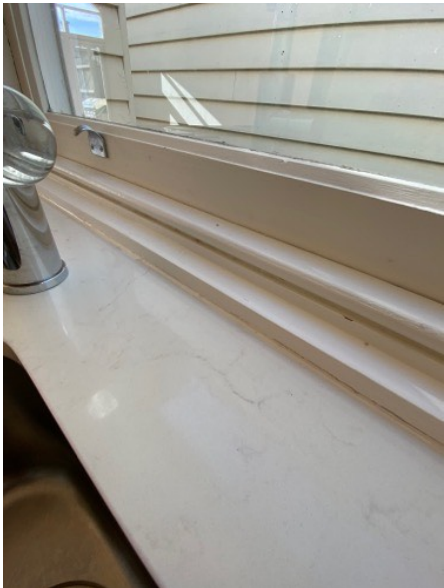
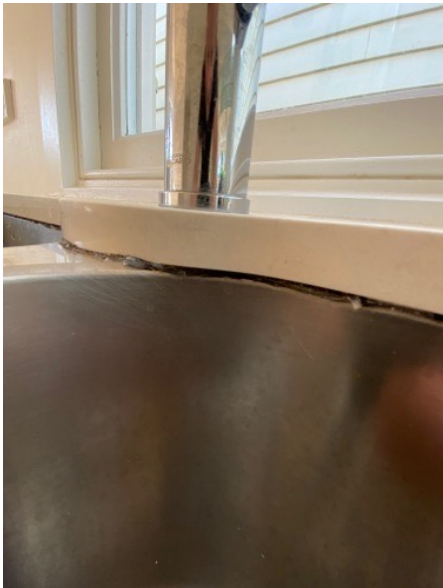
### Minor Defect 3.14

Finding: Sealants Deteriorating

It was noted on inspection that sealant or grout is degraded to the tiled shower alcove and or other areas of the bathroom and kitchen which can allow water to reach the structural materials.

Different materials and floor areas move at different rates, generally causing cracking to grout or sealant at this point. A flexible sealant is required to allow for expected expansion and contraction, while keeping the joint water tight and protective of all associated building materials.

There appears to be mould to the sealant and grout which will likely require scraping out and replacement.

Flexible and mould resistant materials should be applied to affected areas to prevent any subsequent water damage that is likely to occur. Regular maintenance and replacement of damage or missing or damaged sealant and grout is highly recommended to the wet areas, as this is a regular wear and tear defect. Sealant and grouting in areas that come into regular contact with water should be maintained for the long term care of your property.

A sealant specialist or tiling contractor should be appointed to complete these works as soon as possible.

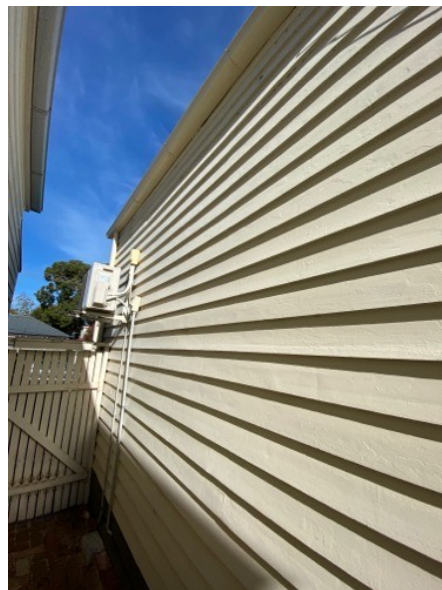
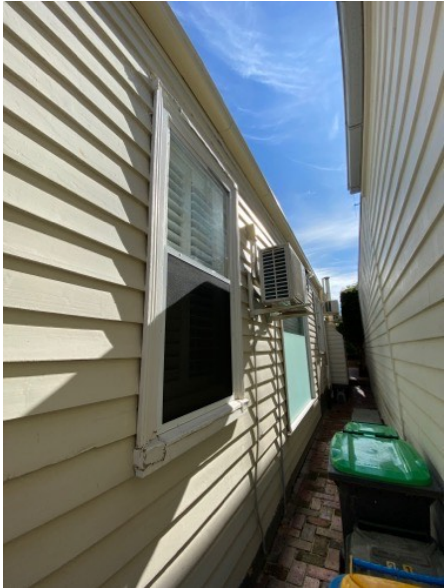
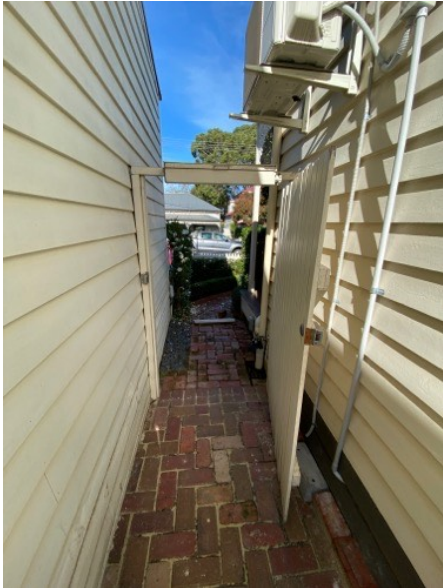
### Minor Defect 3.15

Location: All External Areas

Finding: Timber - exposed to weather  
External timbers/weather boards that are frequently exposed to harsh weather conditions require adequate protection in order to maintain their condition. Where timbers have not been painted or treated adequately, general deterioration is likely to occur at an accelerated rate. If left unattended, replacement of these timbers is likely to be necessary in the short-term future. Adequate treatment of these timbers is required as soon as possible by a painting contractor or general handyman.

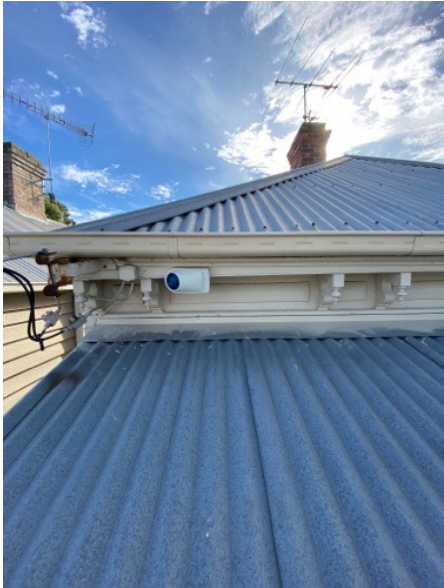
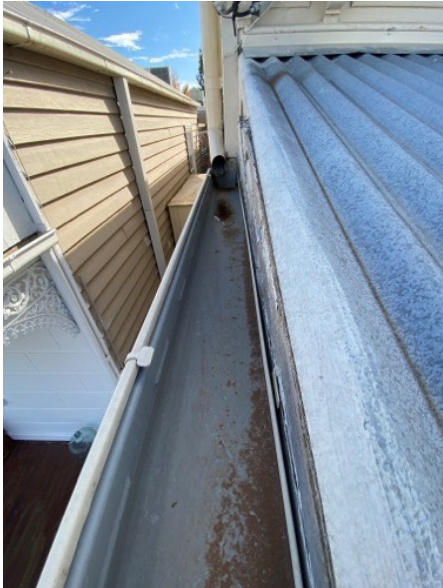
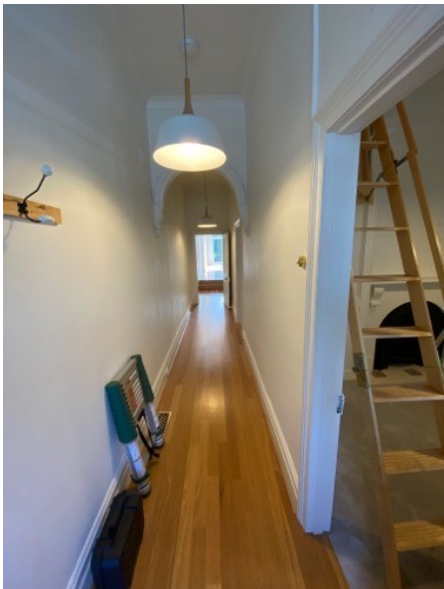
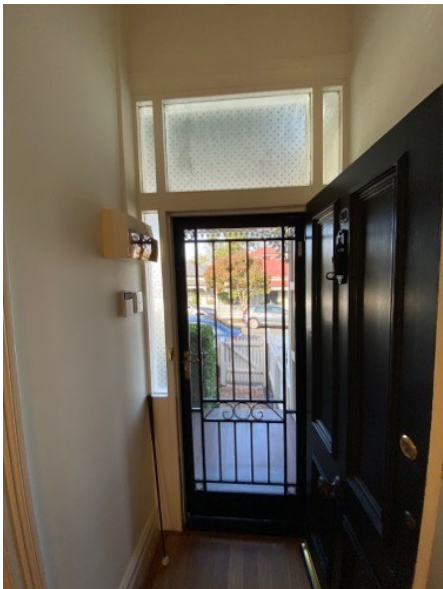
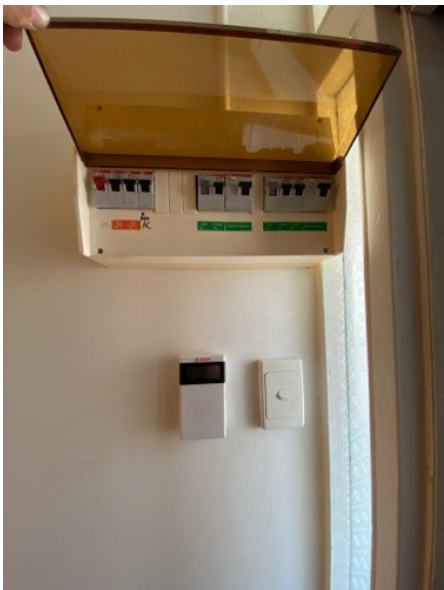
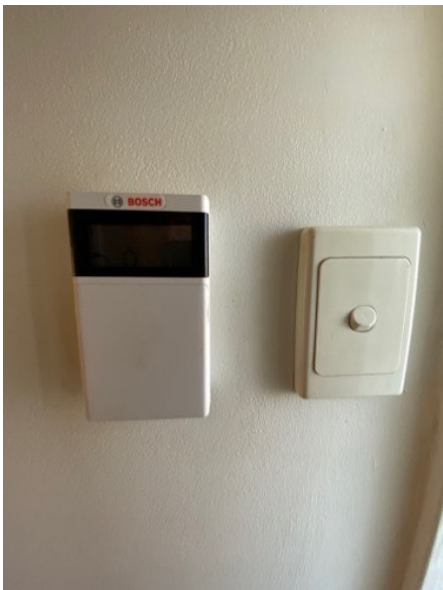
The additional photographs are an indication of the obstructions, stored items, limitations, health and safety limitations, which impeded full inspection of the property at the time of inspection. Obstructions as see in the photos can hide an array of defects and should be removed to allow full inspection to be carried out. A re-inspection is recommended once the areas are made accessible.
