# Property and Timber Pest Report

Inspection Date: 6 May 2020

Property and Timber Pest Report

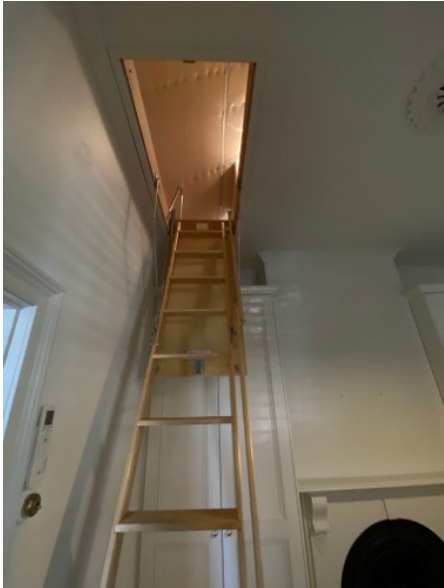
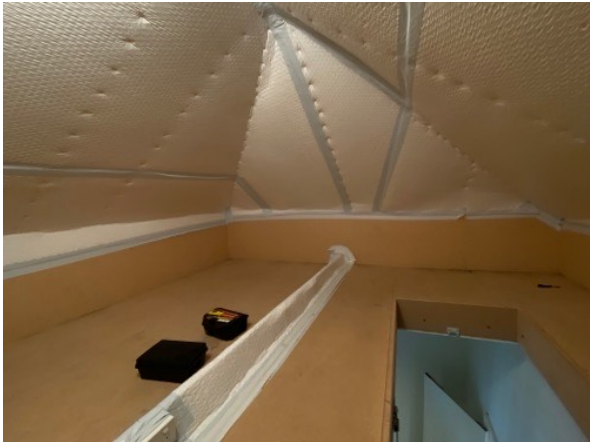
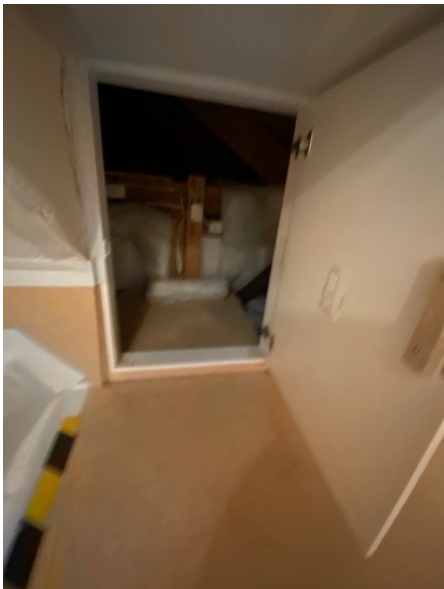
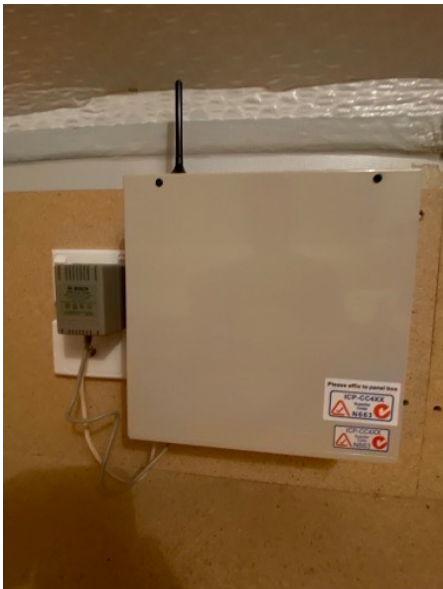
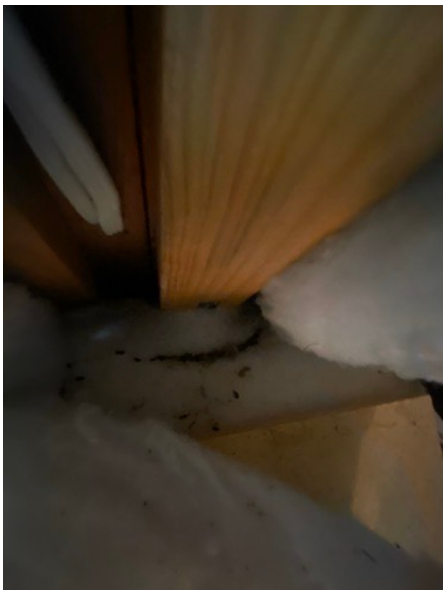
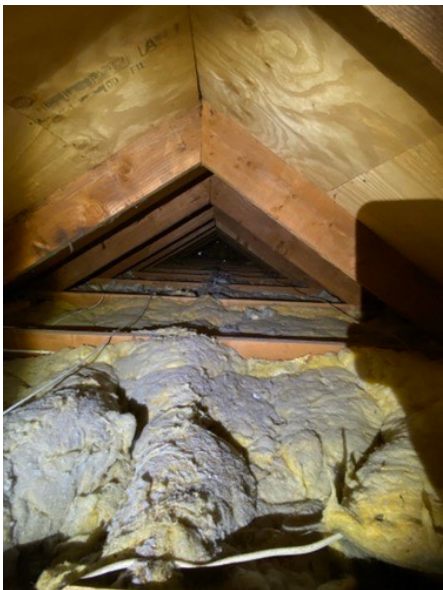
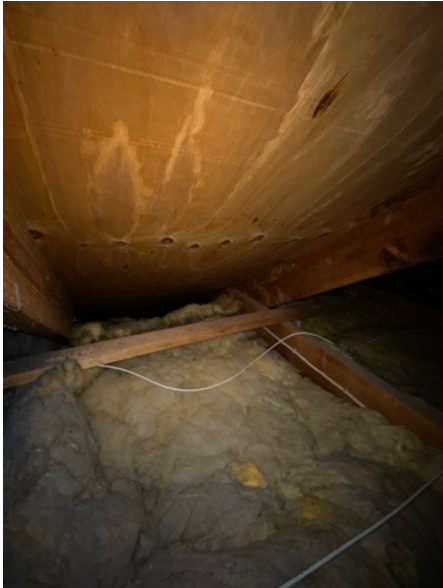
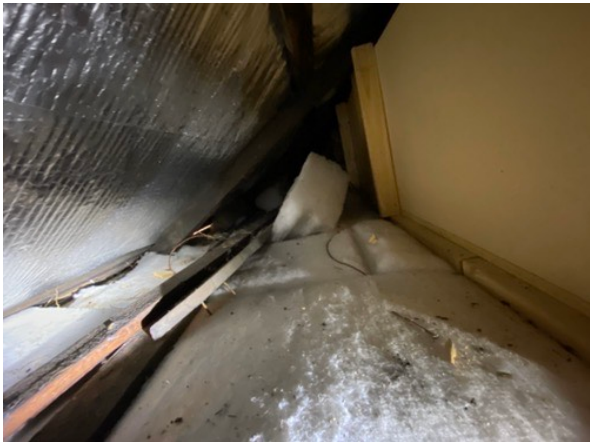
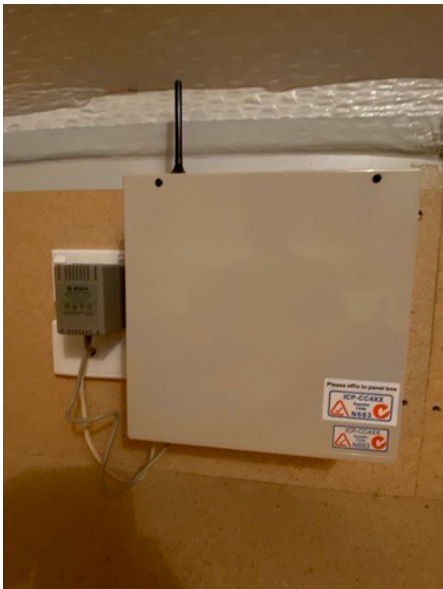
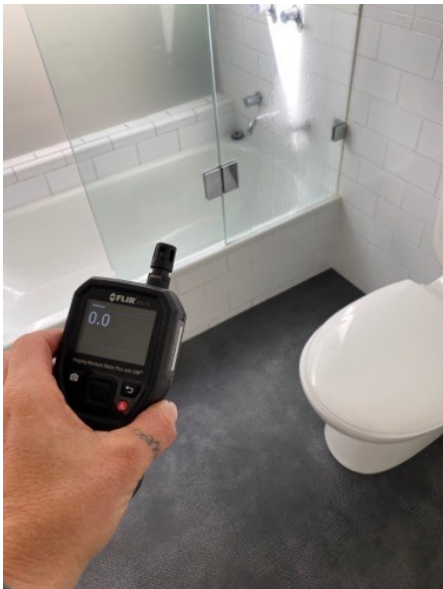
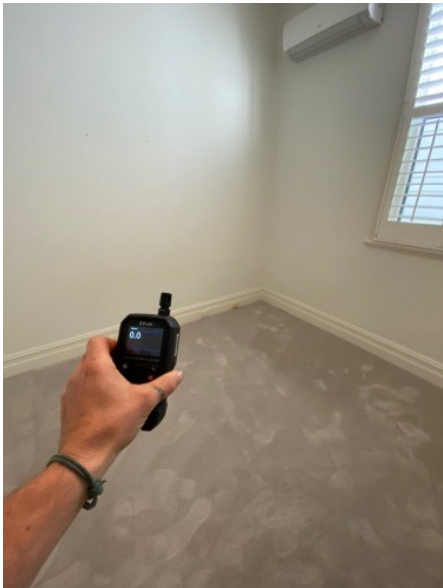
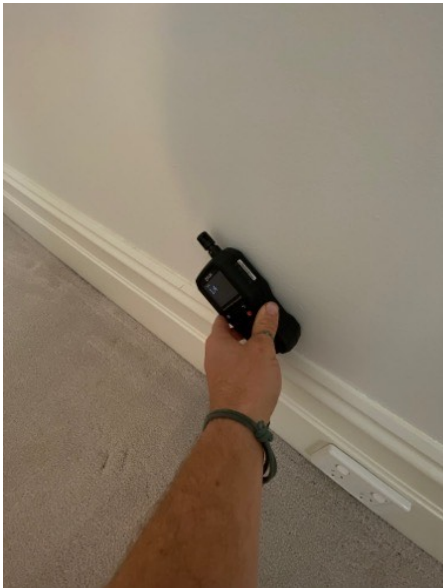
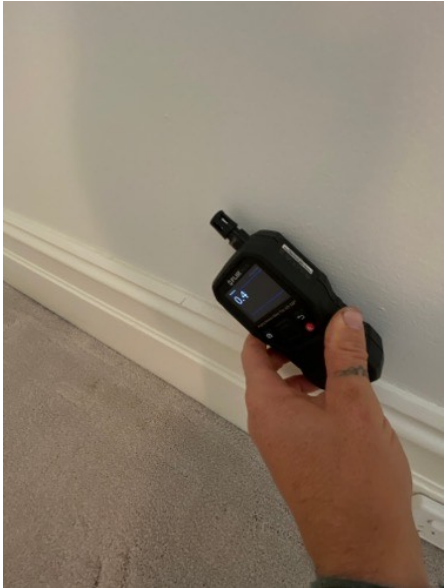
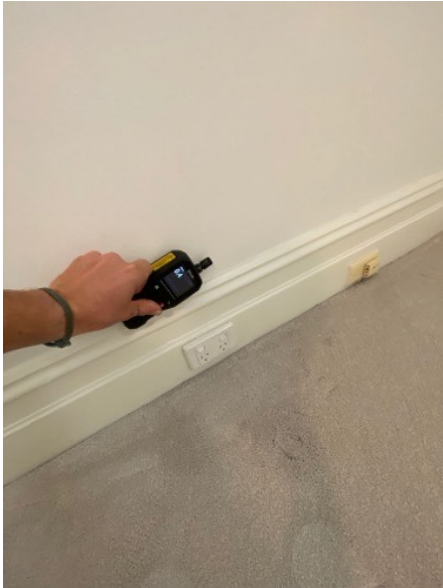
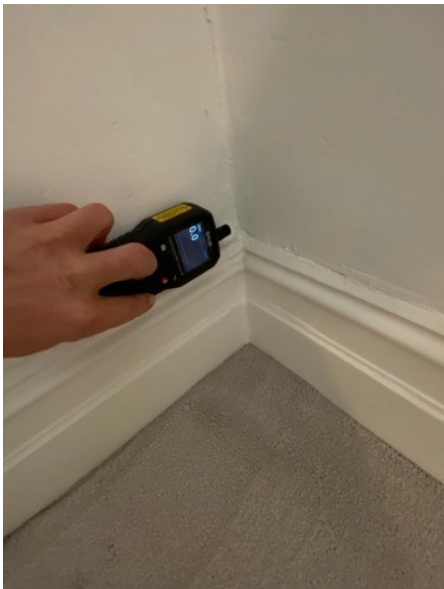
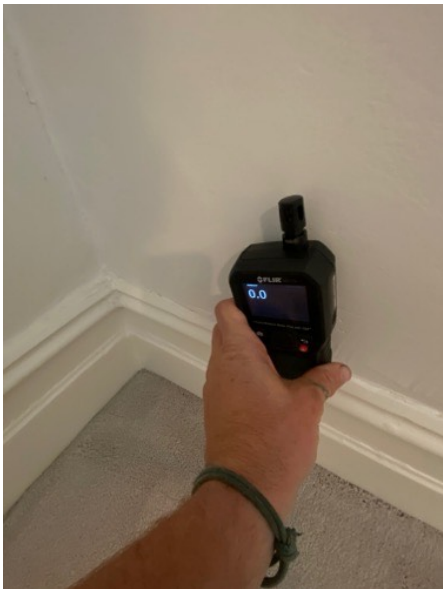
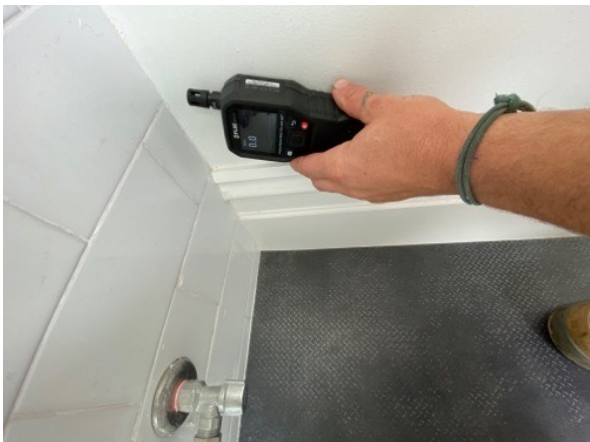
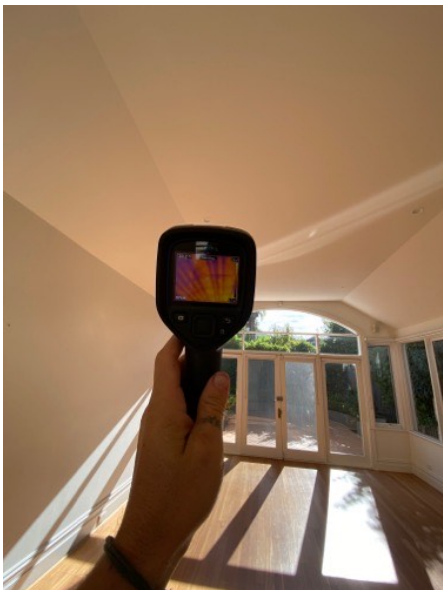
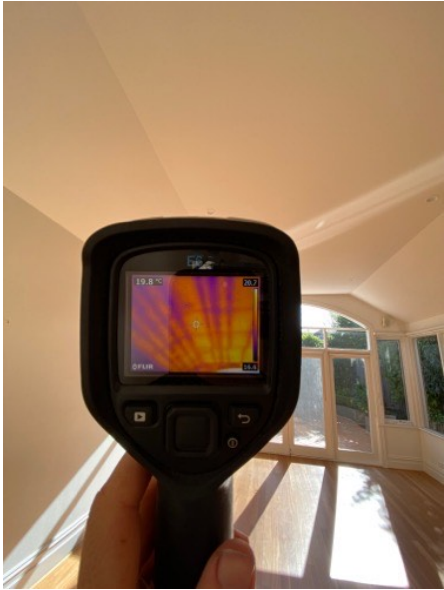
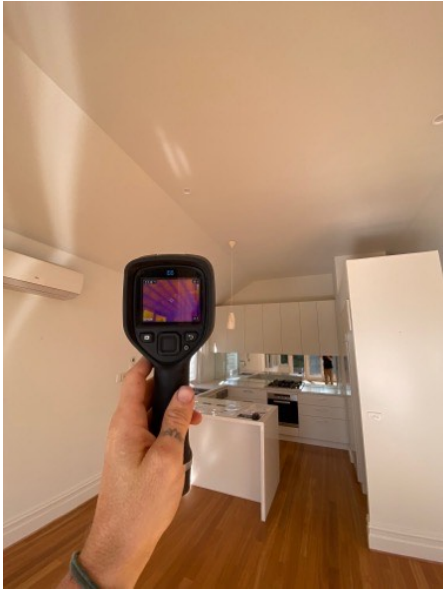
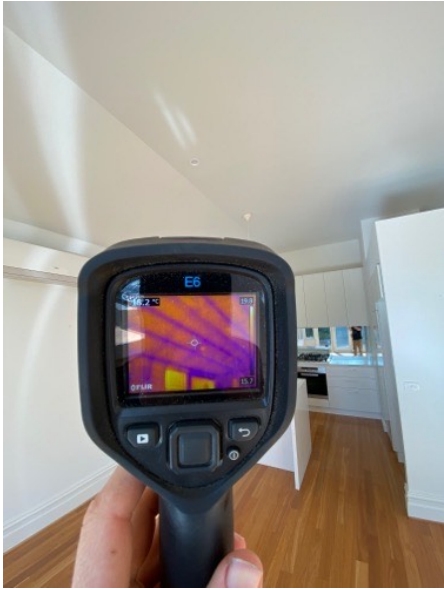
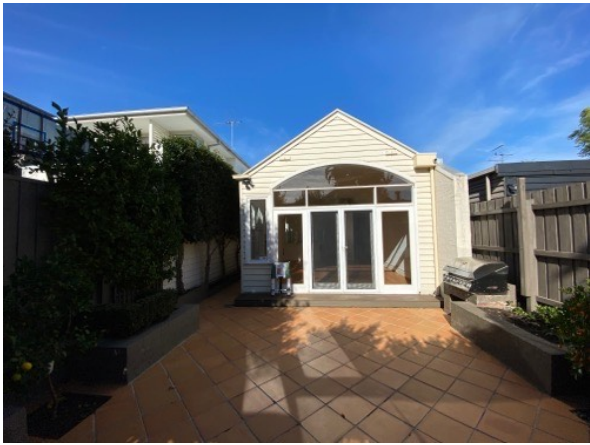
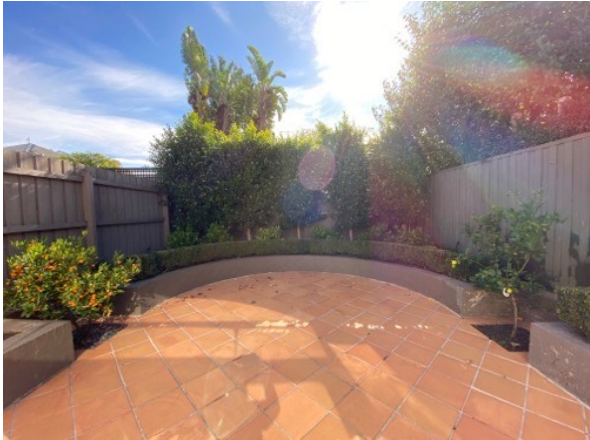
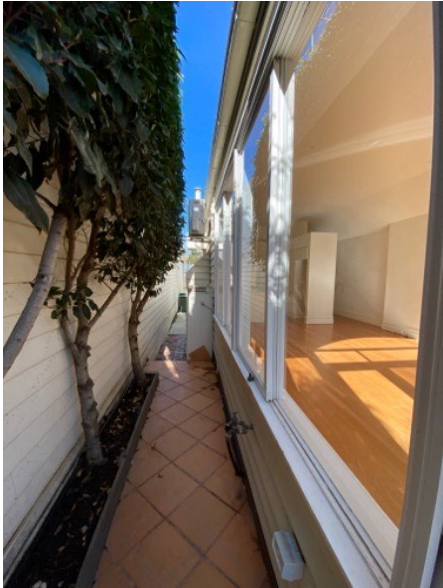
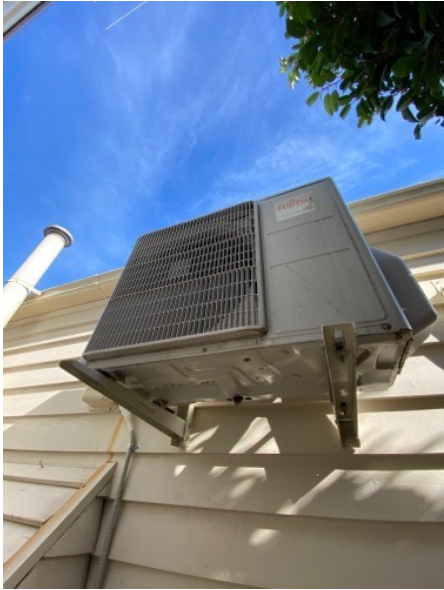
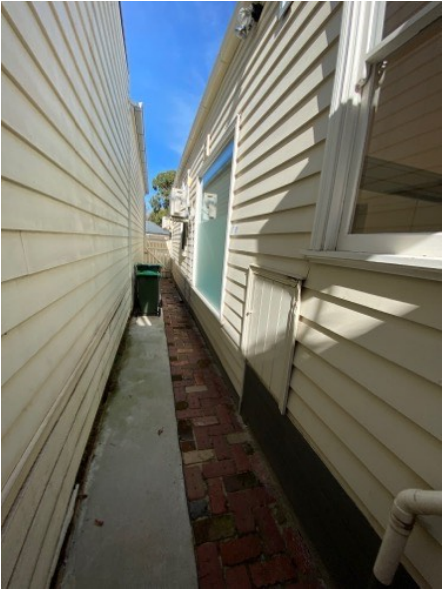
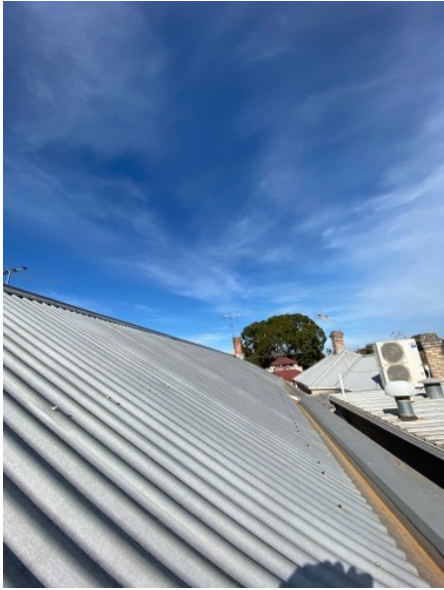
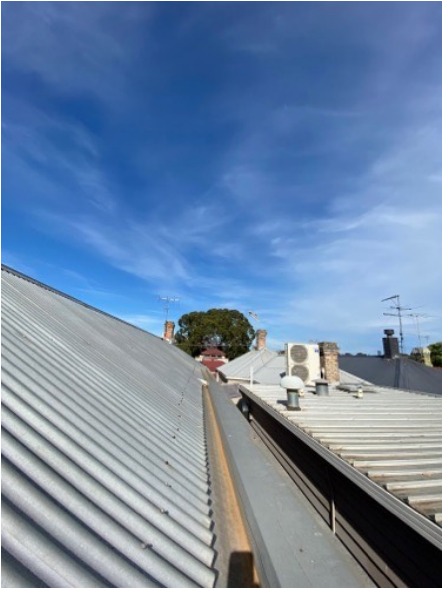
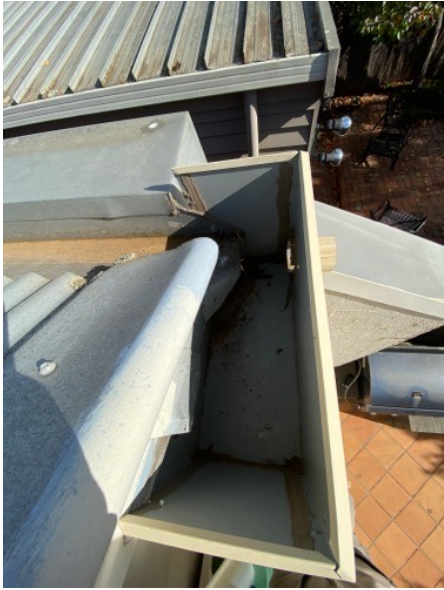
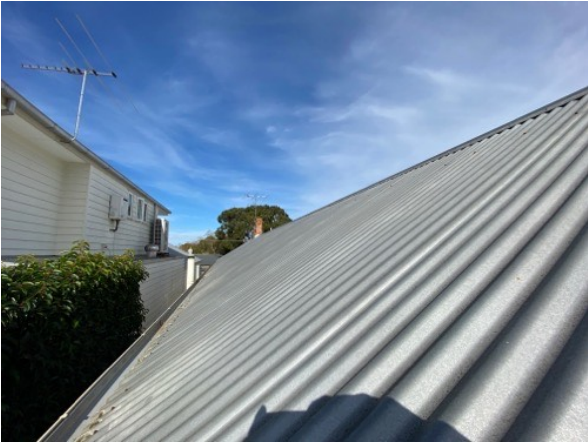
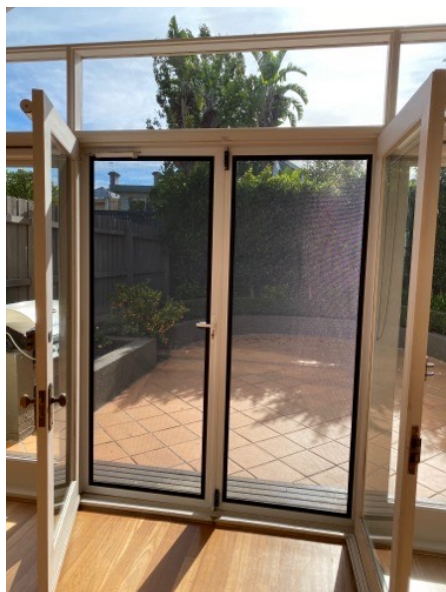
The additional photographs are an indication of the obstructions, stored items, limitations, health and safety limitations, which impeded full inspection of the property at the time of inspection. Obstructions as see in the photos can hide an array of defects and should be removed to allow full inspection to be carried out. A re-inspection is recommended once the areas are made accessible.

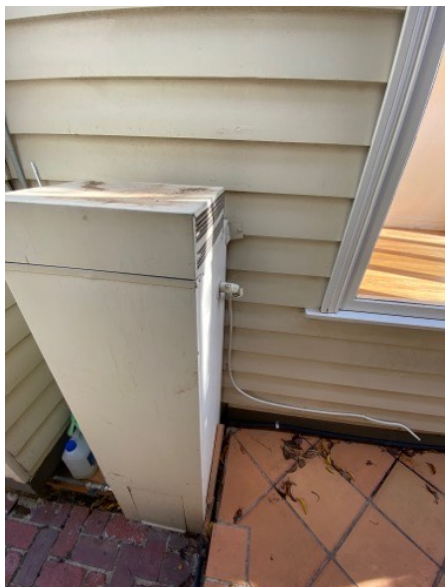
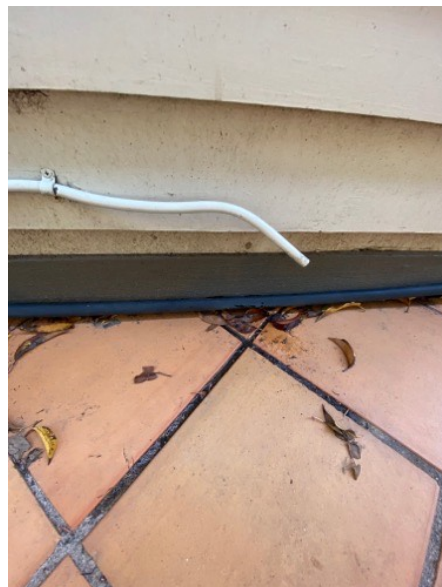
The Hot Water System (HWS) overflow was found to be disconnected from storm water drainage and is creating excessive moisture in the surrounding area.

These damp conditions can lead to secondary defects such as rot, rust or corrosion of associated building elements, the formation of fungal decay, or pooling of water may also attract termite activity to this area.

It is highly recommended that a licensed plumber be appointed to connect the HWS overflow to the storm water in order to prevent such an environment from being created. These minor works should be carried out as soon as possible.

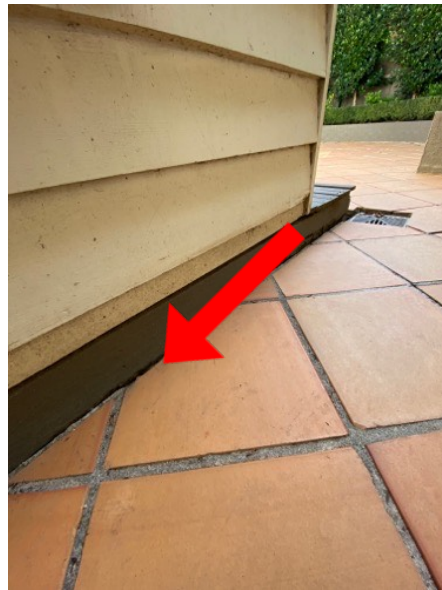
Location: All External Areas

Finding: 1 Building materials in direct ground contact - conducive to termites  
Where stored timber and house barge boards are in contact with ground, they can retain moisture or dampness and become highly conducive to termite activity. External timbers when met with excessive moisture begin to decay, develop wood rot and become conducive to termite activity.  
It's advised the removal of any timbers that are not part of a building structure that may be conducive to termite activity. Due to the location of the property and building timbers in contact with ground it's highly advised that a termite treatment around the property is conducted as there was no evidence of a previous termite management system in place.
